Additional Report of the Japanese Government  
to the IAEA

- The Accident at TEPCO's Fukushima Nuclear Power Stations -  
(Second Report)

September 2011

Nuclear Emergency Response Headquarters  
Government of Japan

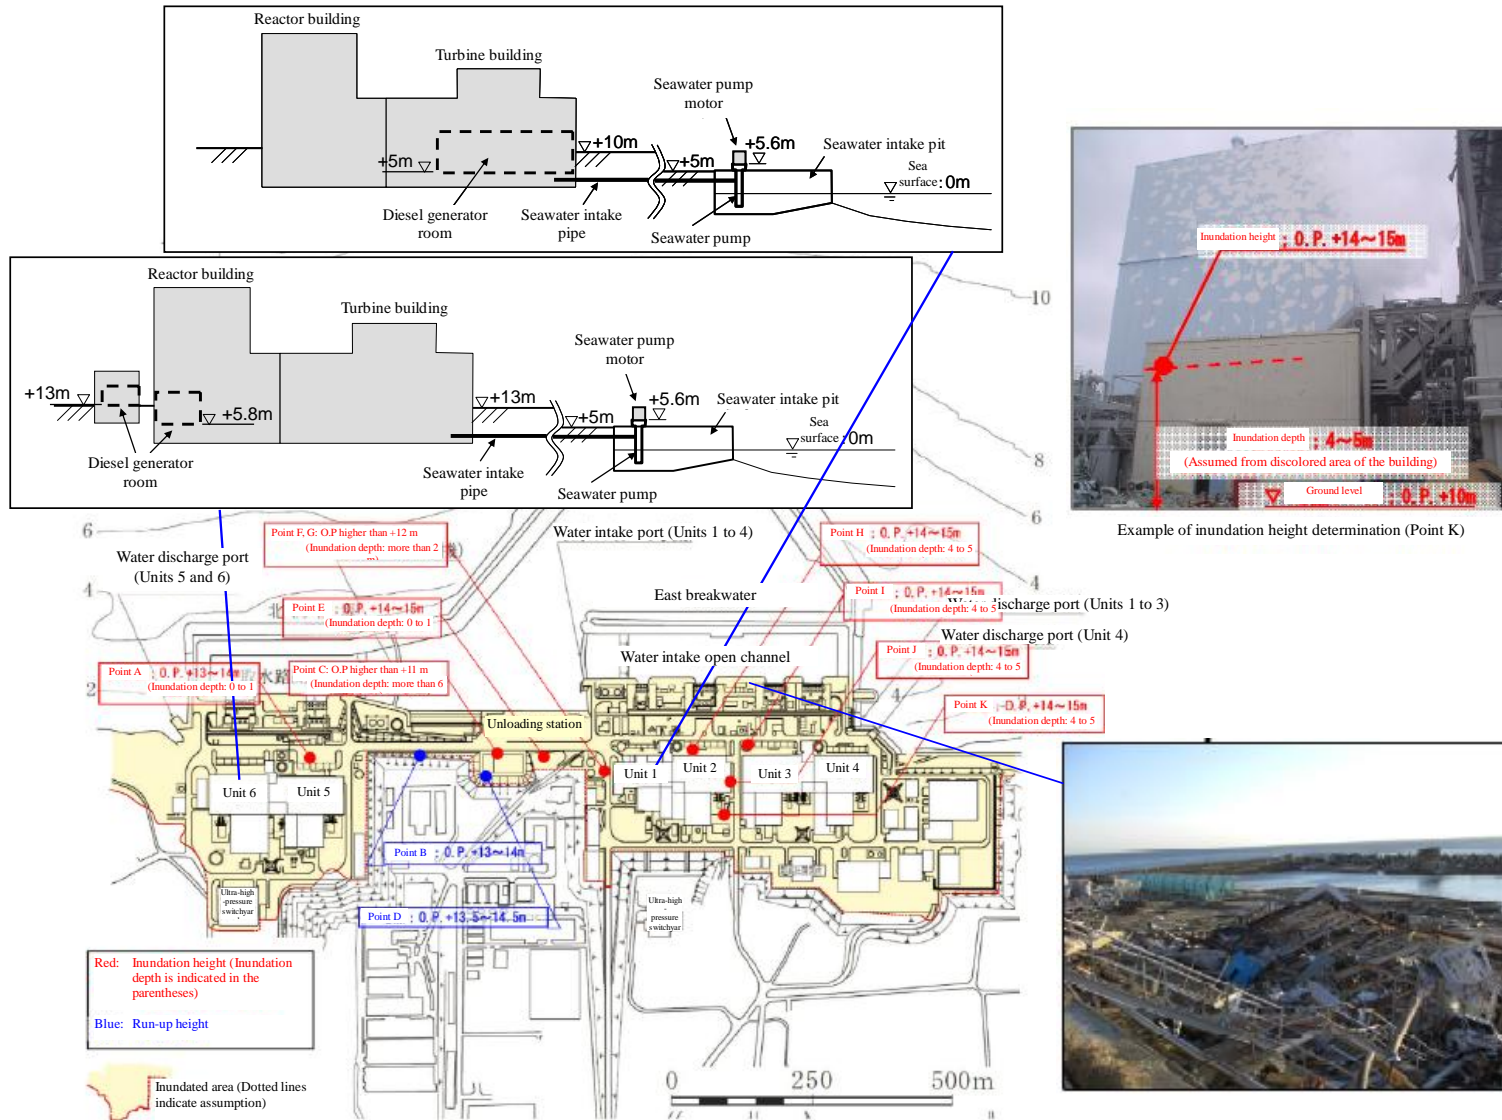
Figure II-2-20 Damage of Fukushima Dai-ichi NPS due to the Tsunami

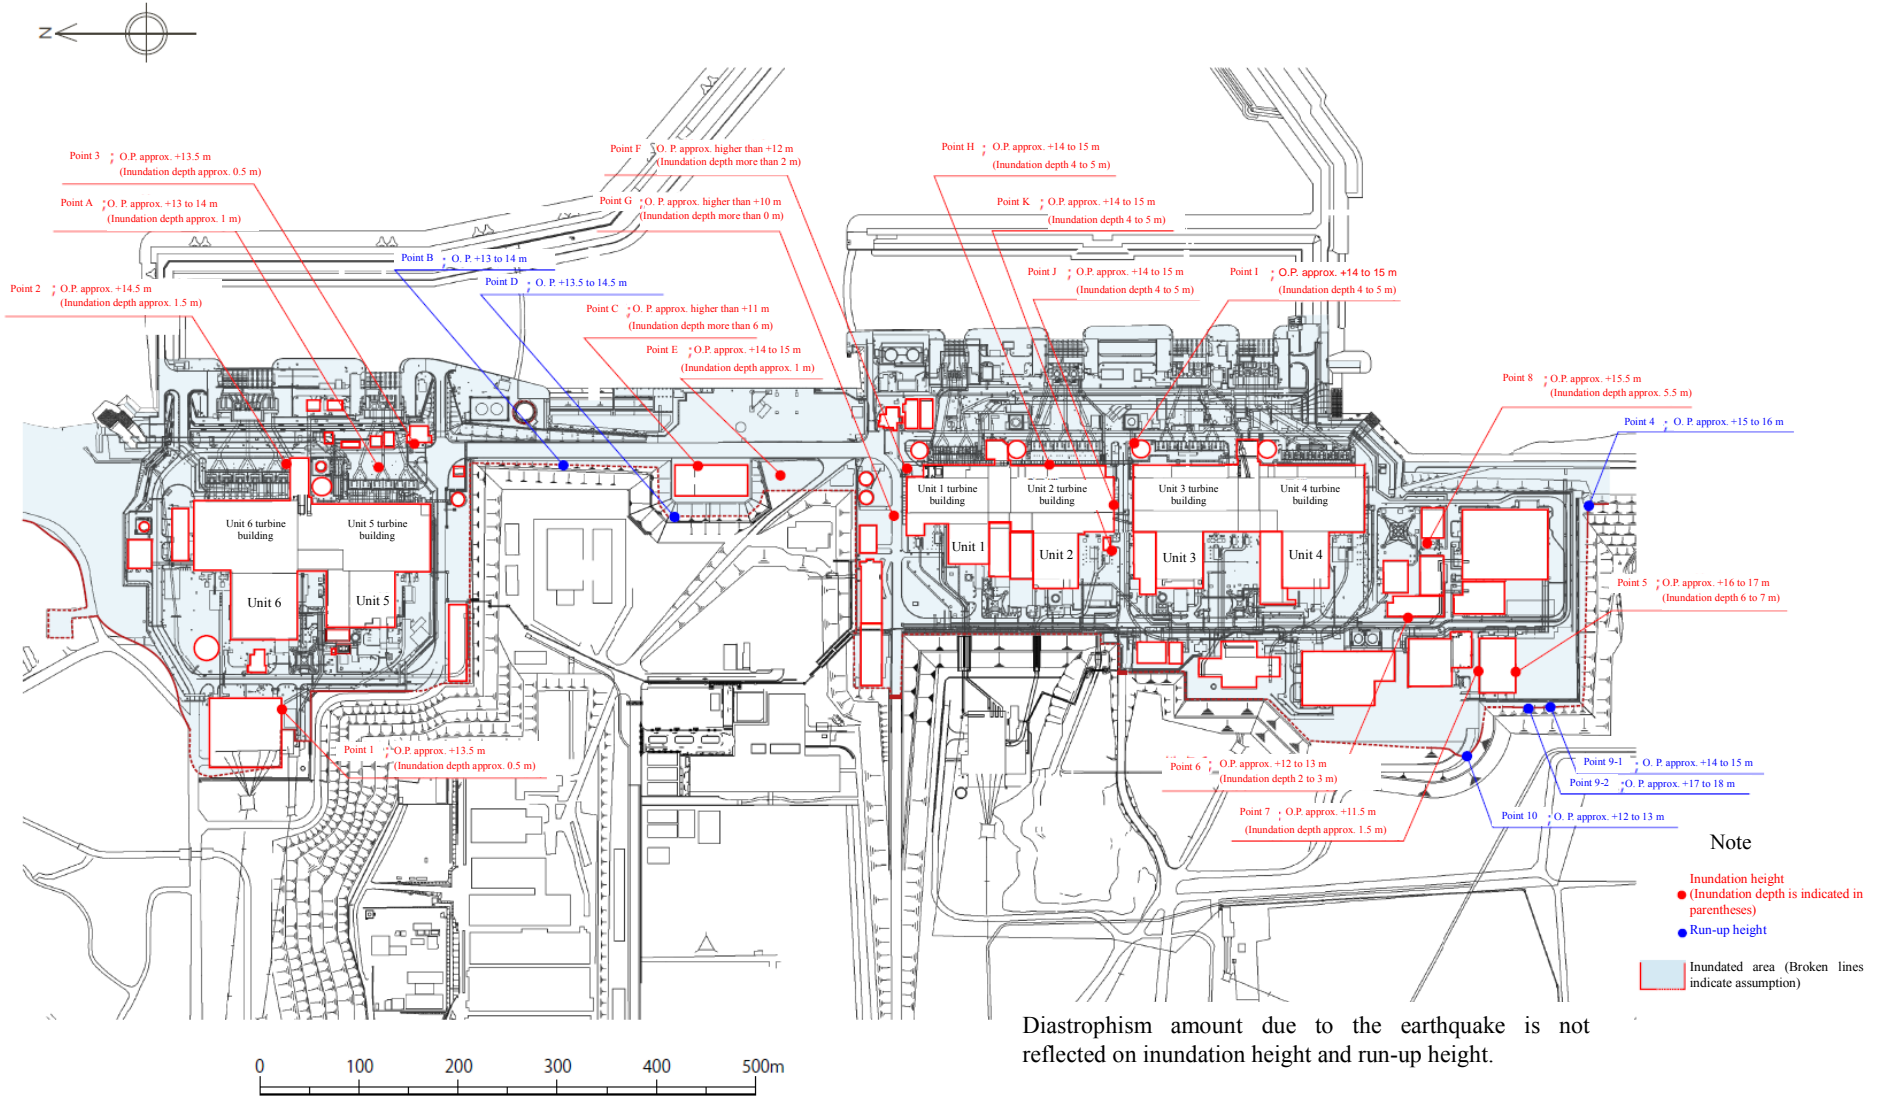
Figure II-2-23 Investigation Result of Tsunami at Fukushima Dai-ichi NPS (Inundation height, inundation depths and inundated area)

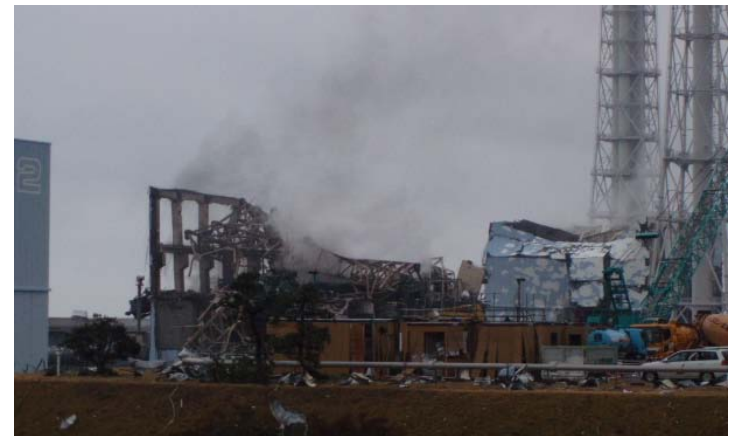
Figure II-2-26 Condition of Reactor Buildings, Units 1 to 4, Fukushima Dai-ichi NPS

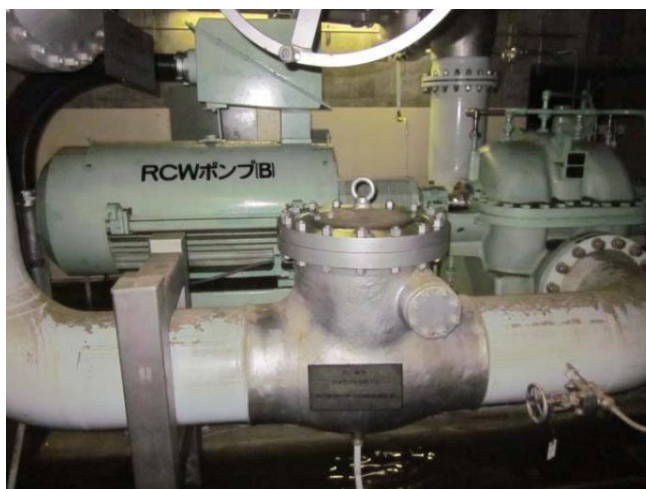
RCW pump (B) (after seawater was drained)

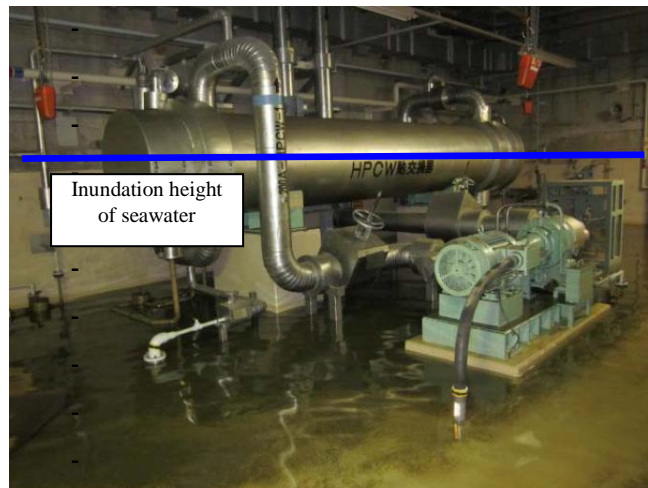
Seawater flooding in the HPCW heat exchanger chamber

Fig. II-2-143 Seawater flooding condition

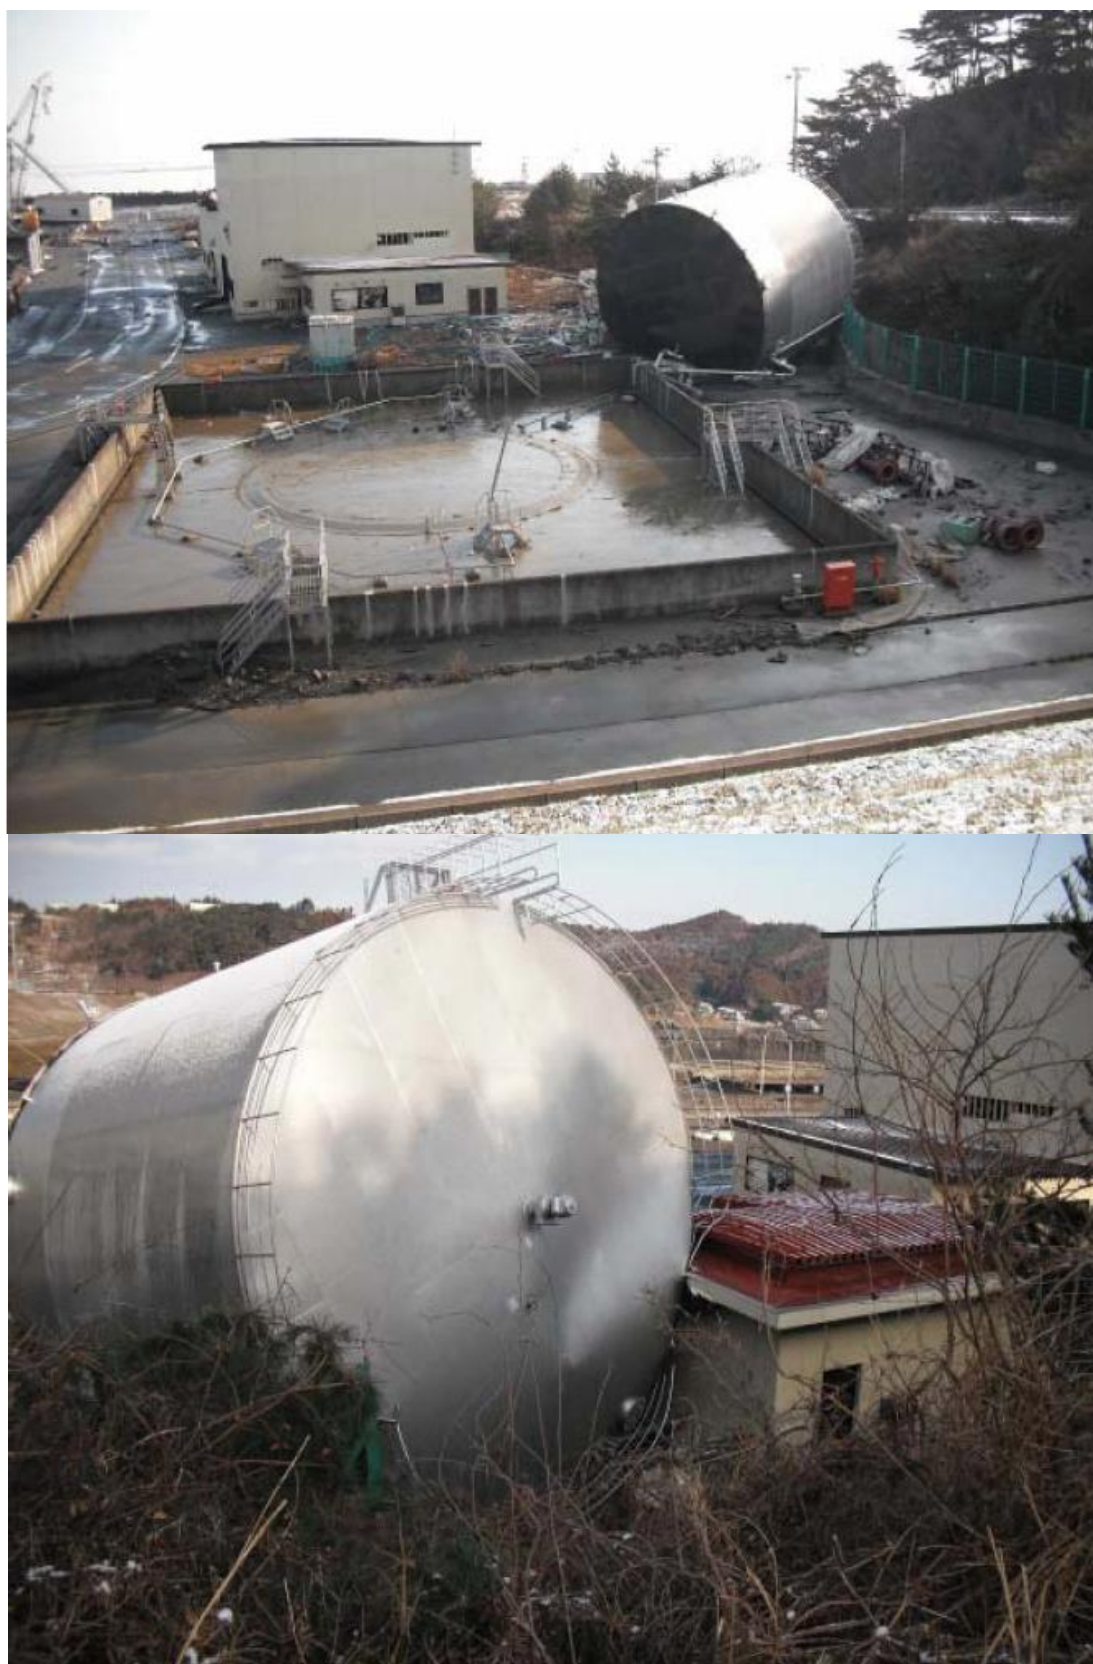
Fig. II-2-149 Collapsed heavy oil tank

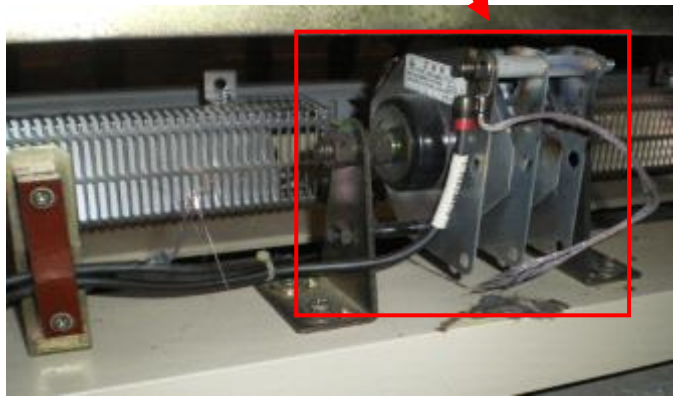
\* 2 out of 12 diodes (6 pairs) short-circuited.

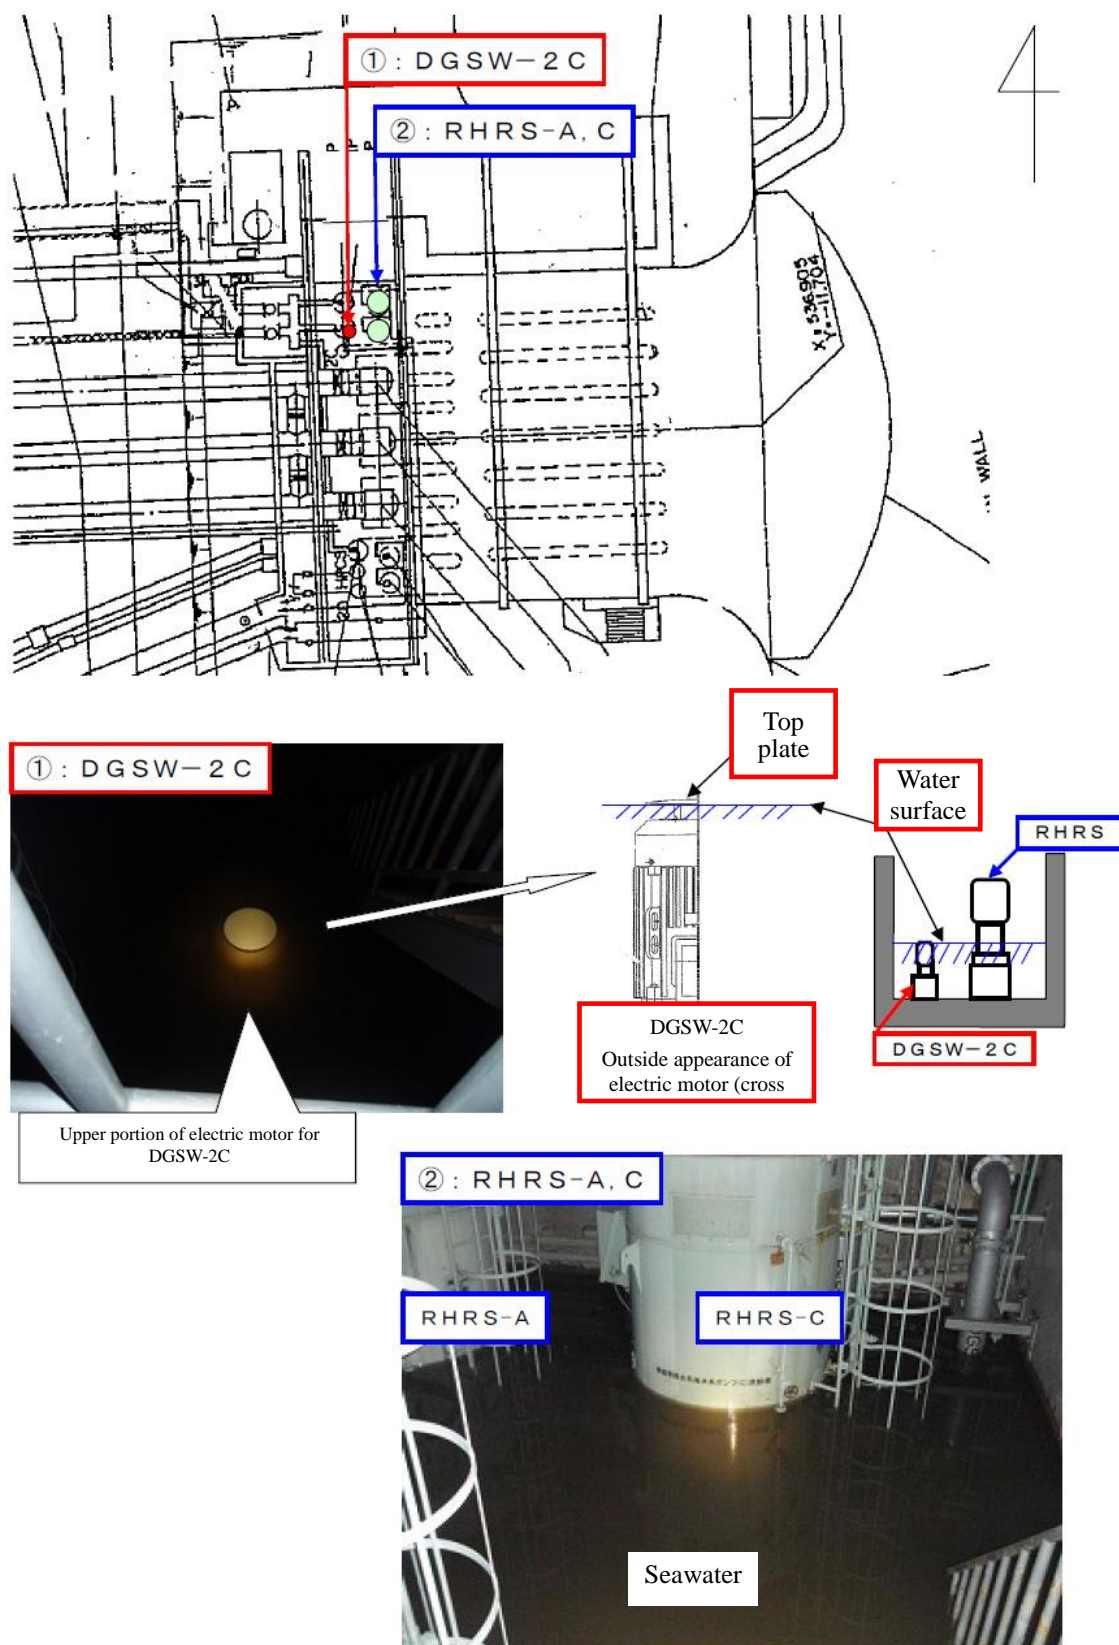
Fig. II-2-170 Status of Seawater Invasion in Water Intake Pump Vessel on March 11
