Additional Report of the Japanese Government  
to the IAEA

- The Accident at TEPCO's Fukushima Nuclear Power Stations -  
(Second Report)

September 2011

Nuclear Emergency Response Headquarters  
Government of Japan

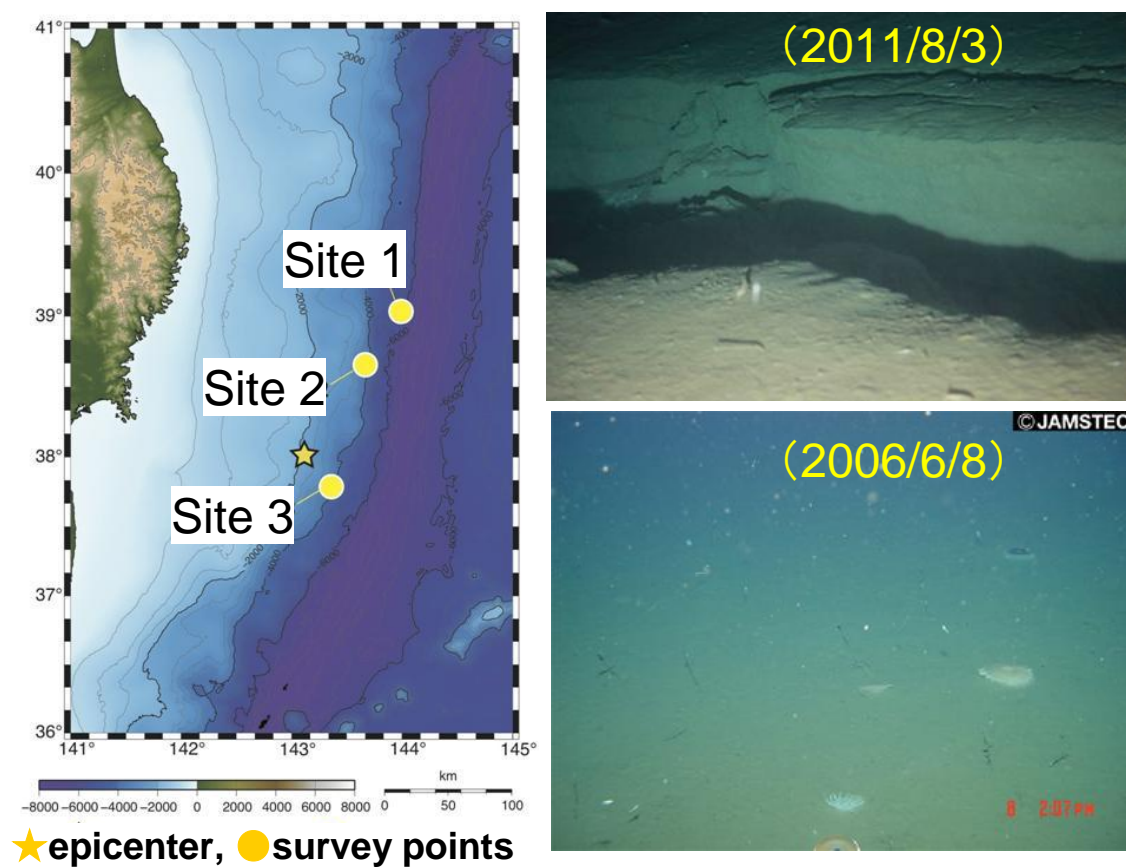
Fig. II-1-4 Results of underwater surveys of the seismic source area by “Shinkai 6500”.

The Japan Agency for Marine-Earth Science and Technology (JAMSTEC), an independent administrative institution, conducted a seismic reflection survey and a seafloor topography survey using bathymeters, etc. in the source area of the Tohoku earthquake during March 15 to 31, 2011. Based on the results of the seafloor topography survey, JAMSTEC published that a particularly large displacement had been found on the west side of the trench axis. JAMSTEC indicated that the displacement represented a seafloor topographic change caused by the Tohoku earthquake, and also noted that a zone extending from the vicinity of the hypocenter of the main quake to the trench axis (the area on the west side of the trench axis) may have moved in a southeasterly to east-southeasterly direction by about 50 m, and raised about 7 m. In addition, on July 30 to August 14, 2011, JAMSTEC conducted a submersible exploration using the manned submersible research vehicle “Shinkai 6500” at the landward slope along the Japan Trench in the source sea area of the Tohoku earthquake (Figure II-1-4). The results of the exploration confirmed a crack extending about 80 m or more in a north-south direction, with a width and depth of about 1 m, in

a location where previous surveys had found no cracks (Figure II-1-4, Site 1). JAMSTEC indicated that the crack was likely to be caused by a sequence of seismic activities including the Tohoku earthquake.

Right top figure: surface crack found at site 1 after the main quake (Aug.3, 2011, No 1256 submerging).

Right bottom figure: surface without crack at site 1 before the main quake (June 8, 2006, No 957 submerging).

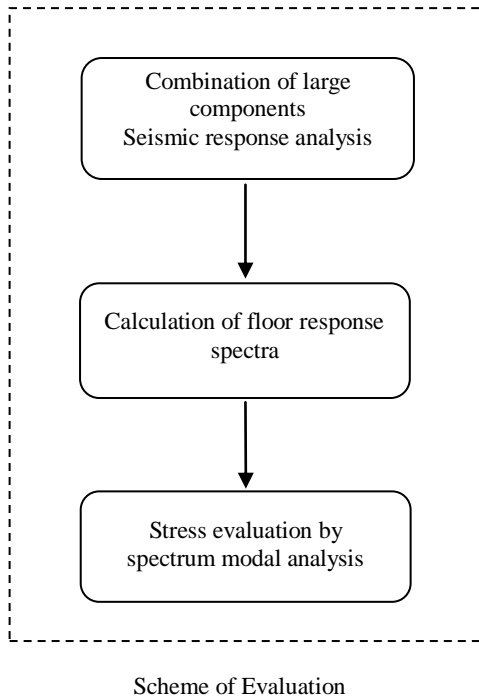
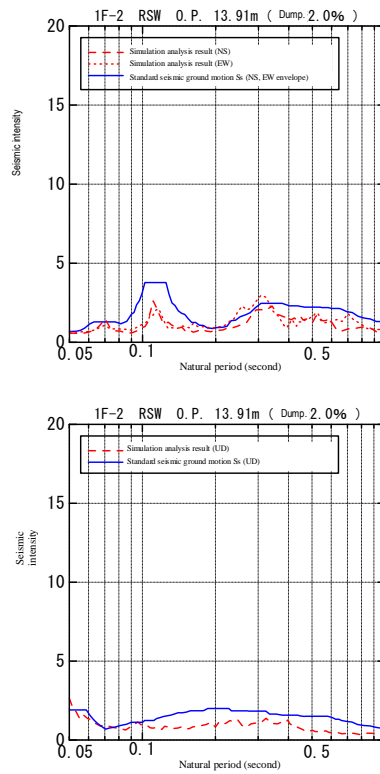
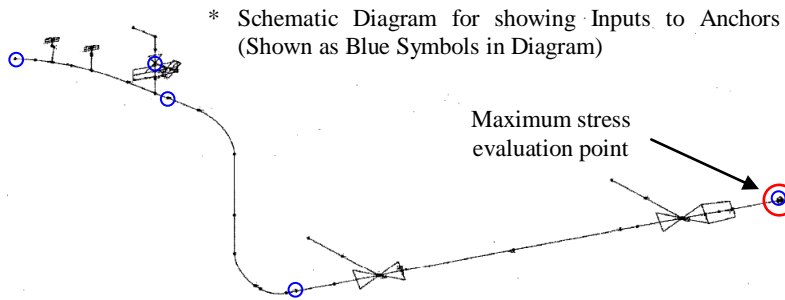
Table II-2-9 Outline of Seismic Evaluation (Example of Main Steam System Piping)

The floor response spectra of this earthquake are generally less than those of standard seismic ground motion Ss. It is in part of the periodic band that the floor response spectra of this earthquake are greater than those of standard seismic ground motion Ss.

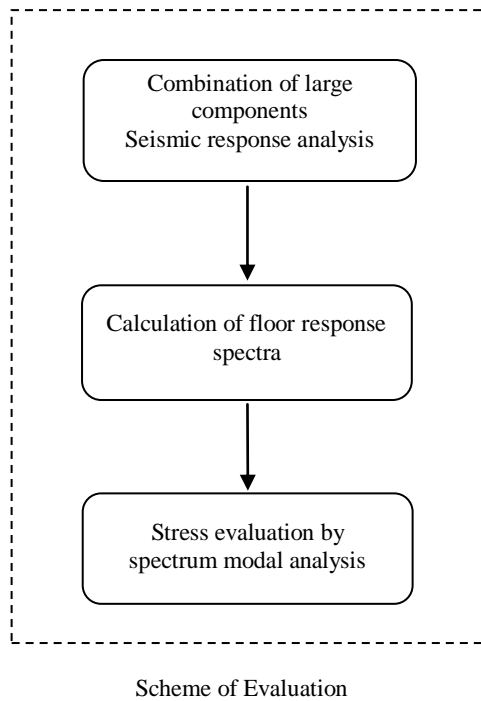
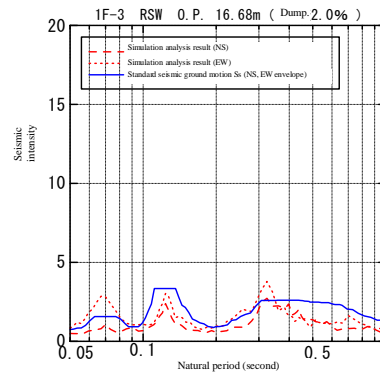
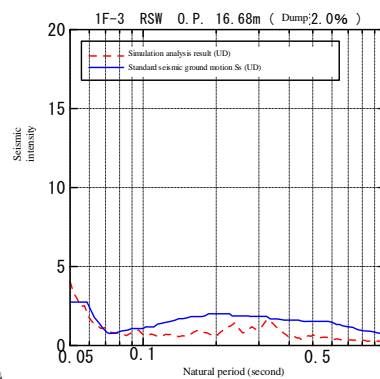
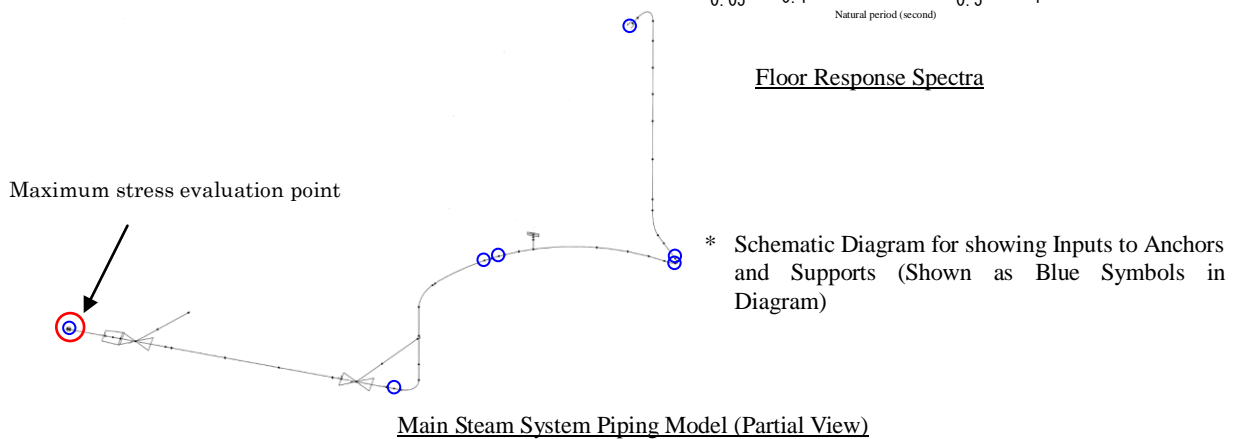
Table II-2-10 Outline of Seismic Evaluation (Example of Main Steam System Piping)  
(Fukushima Dai-ichi NPS, Unit 3)

Equipment concerned	Evaluated portion	Standard seismic ground motion S <sub>s</sub>				This earthquake			
		Stress classification	Calculated value (MPa)	Evaluation criteria value (MPa)	Evaluation technique	Stress classification	Calculated value (MPa)	Evaluation criteria value (MPa)	Evaluation technique
Main steam system piping	Main body of piping	Primary	183	417*	Details	Primary	151	378*	Details

\*: The evaluation reference value for standard seismic ground motion S<sub>s</sub> and that for this earthquake are different from each other because piping materials at their maximum stress evaluation points (locations with a minimum seismic margin) are different.

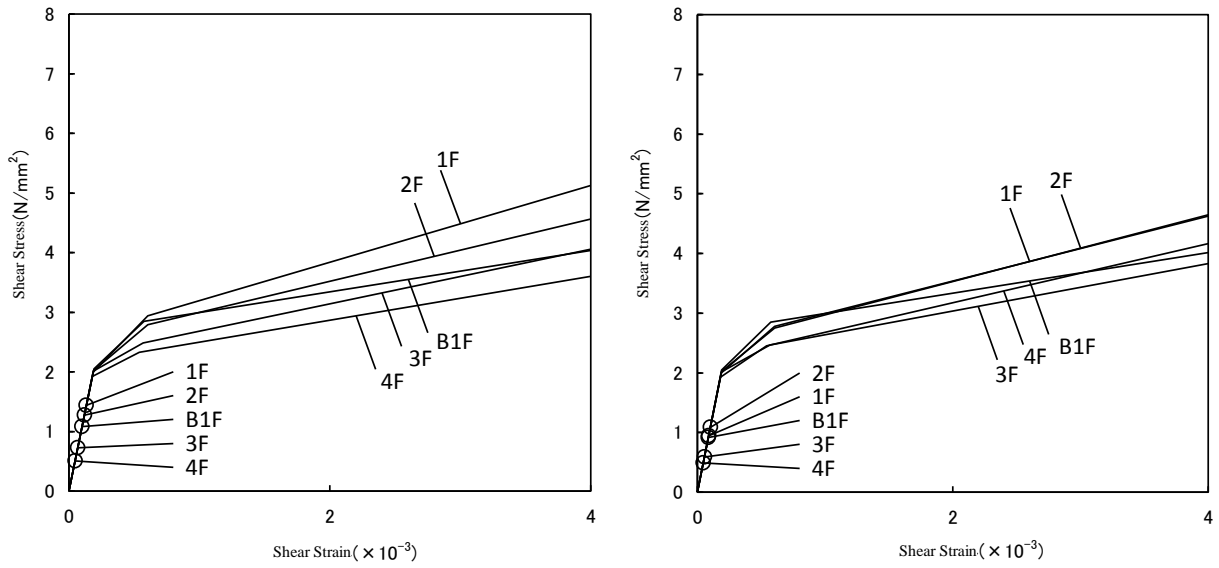
Figure II-2-8 Shear Strain on Seismic Wall (Left: NS Direction, Right: EW Direction)  
(Fukushima Dai-ichi NPS, Unit 1)

The earthquake response analysis found that the maximum shear strain of the seismic wall at each Unit was:  $0.14 \times 10^{-3}$  (north-south, 1st floor) at Unit 1;  $0.43 \times 10^{-3}$  (east-west, 5th floor) at Unit 2;  $0.17 \times 10^{-3}$  (east-west, 5th floor) at Unit 3;  $0.15 \times 10^{-3}$  (east-west, 5th floor) at Unit 4;  $0.36 \times 10^{-3}$  (east-west, 5th floor) at Unit 5; and  $0.16 \times 10^{-3}$  (east-west, 4th floor) at Unit 6, and that the stress and strain of all seismic walls, except the east-west wall on the 5th floor at Unit 2 and the east-west walls on the crane floor and the 5th floor at Unit 5, was below the first knee point on the skeleton curve (the condition of reactor buildings able to keep safety function) (Figures II-2-8 to II-2-13).

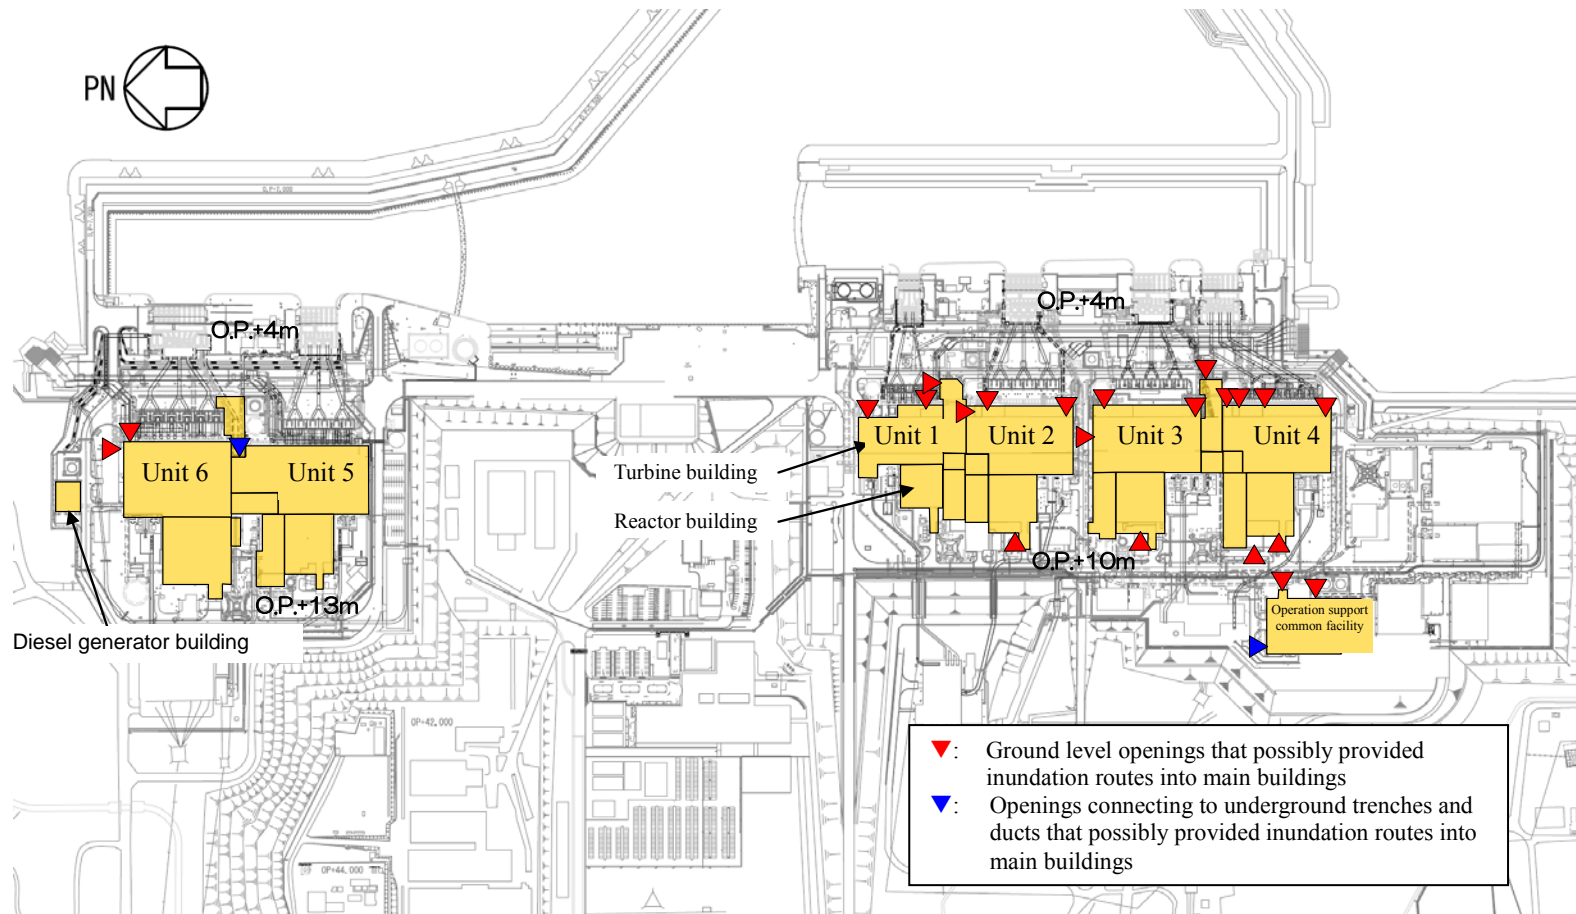
In addition, due to inundation, some parts of the openings on the ground of main building (entrance of building, equipment hatch, and exhaust port) and the opening connected to trench and duct buried under the ground of the site (penetrations slots for cable and pipe) were estimated to be flooding routes into buildings, and it was found that, mainly in the east side (the sea side) of Units 1 to 4 of turbine building, parts of doors and shutters, etc. were damaged by tsunami. It is estimated that, in the inside of the buildings, wide range of the basement was flooded through passageway and stairs room. Location of the opening conceivable to be the flooding routes to the main building is shown in Figure II-2-25.

Figure II-2-24 Result of Tsunami Simulation at Fukushima Dai-ichi NPS (Inundation depth and inundated area)

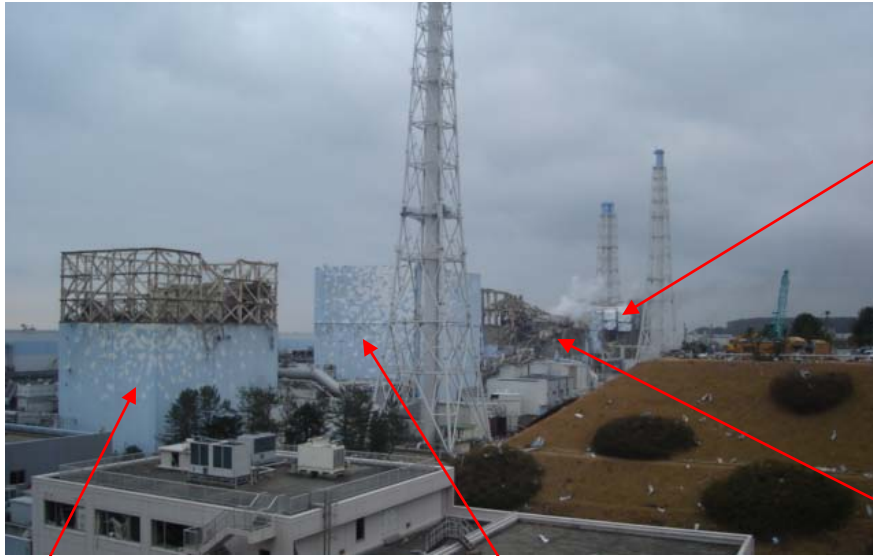
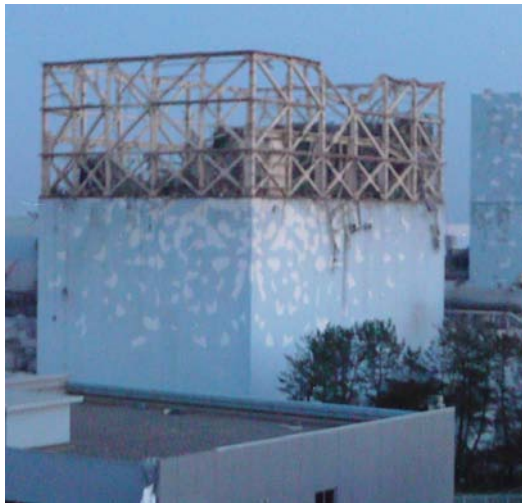
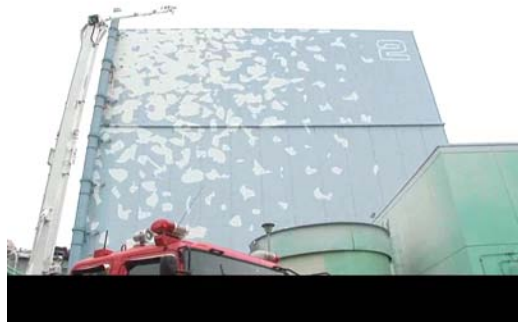
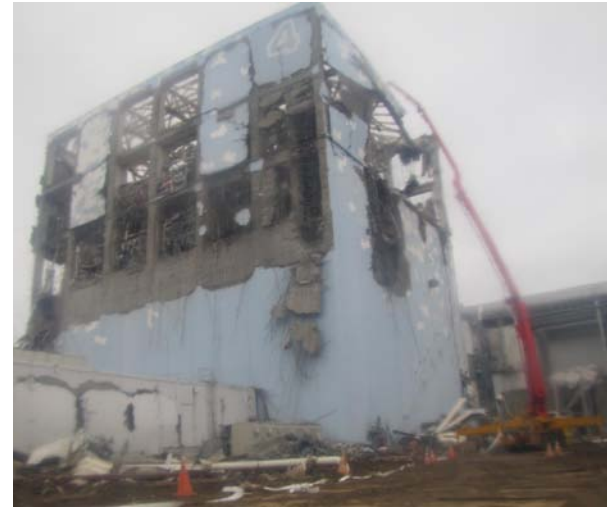
Units 1 to 4 (Units 1, 2, 3 and 4 from foreground)

Figure II-2-26 Condition of Reactor Buildings, Units 1 to 4, Fukushima Dai-ichi NPS

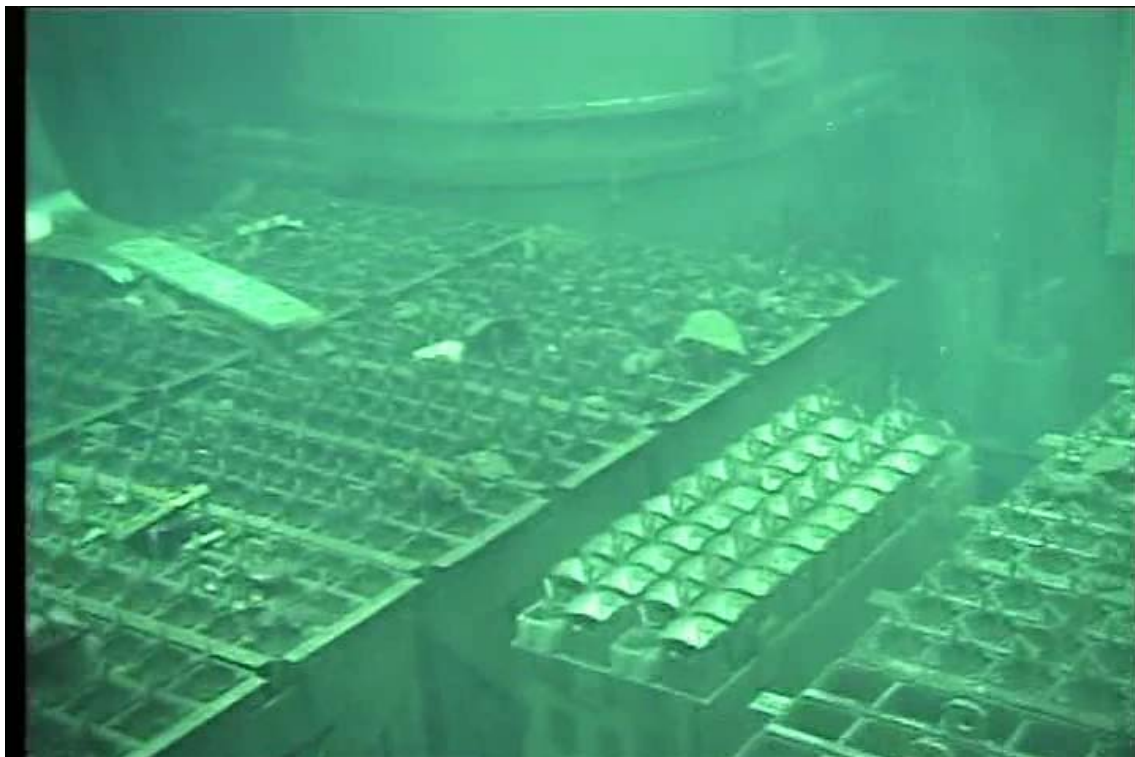
Figure II-2-46 Unit 4 Pool Viewed from Underwater (No. 1)

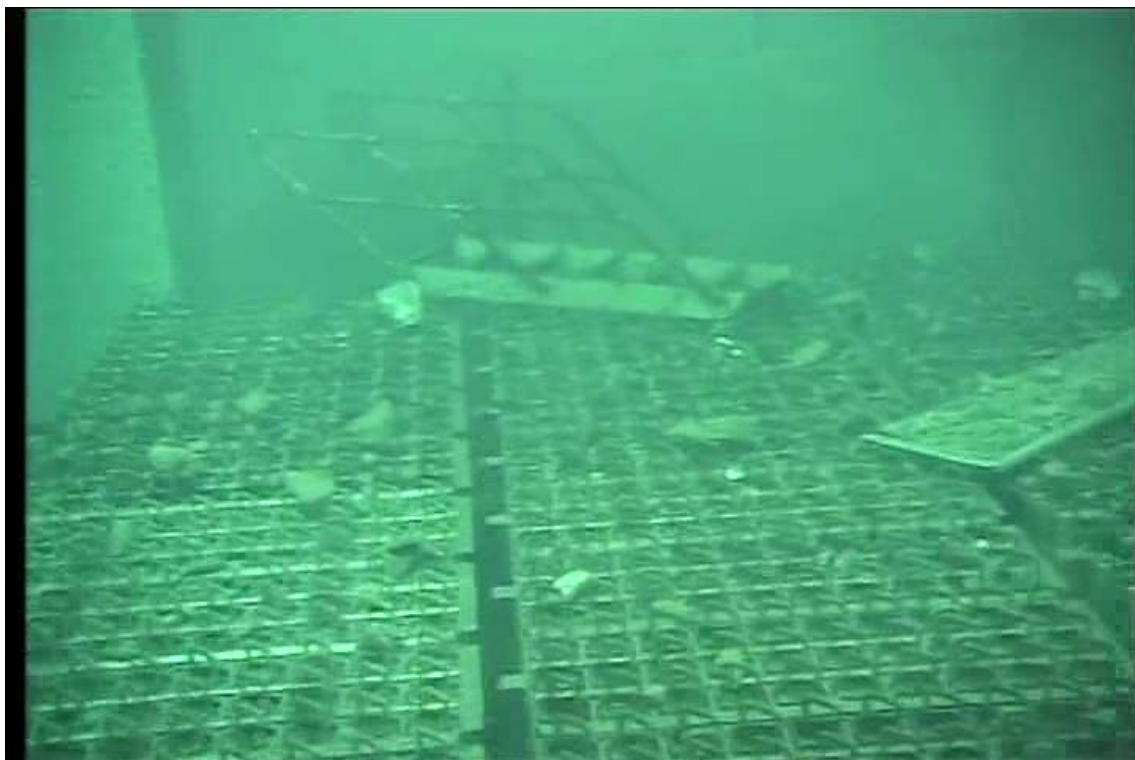
Figure II-2-47 Unit 4 Pool Viewed from Underwater (No. 2)

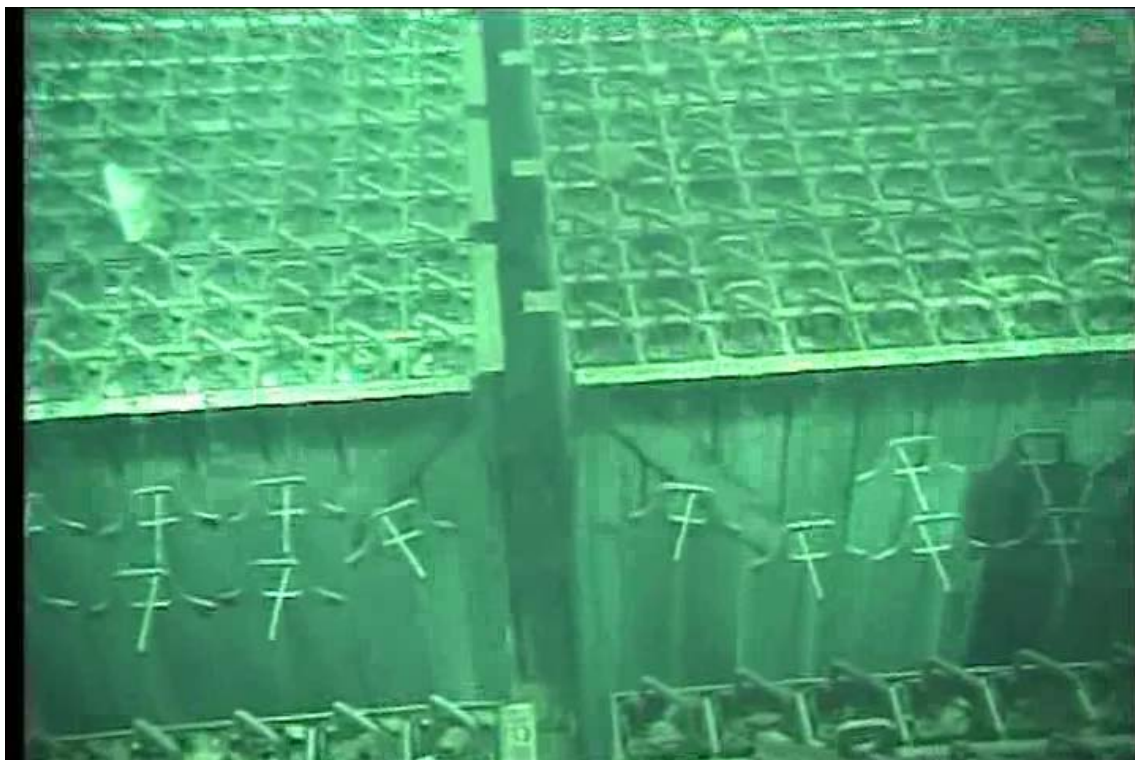
Figure II-2-48 Unit 4 Pool Viewed from Underwater (No. 3)

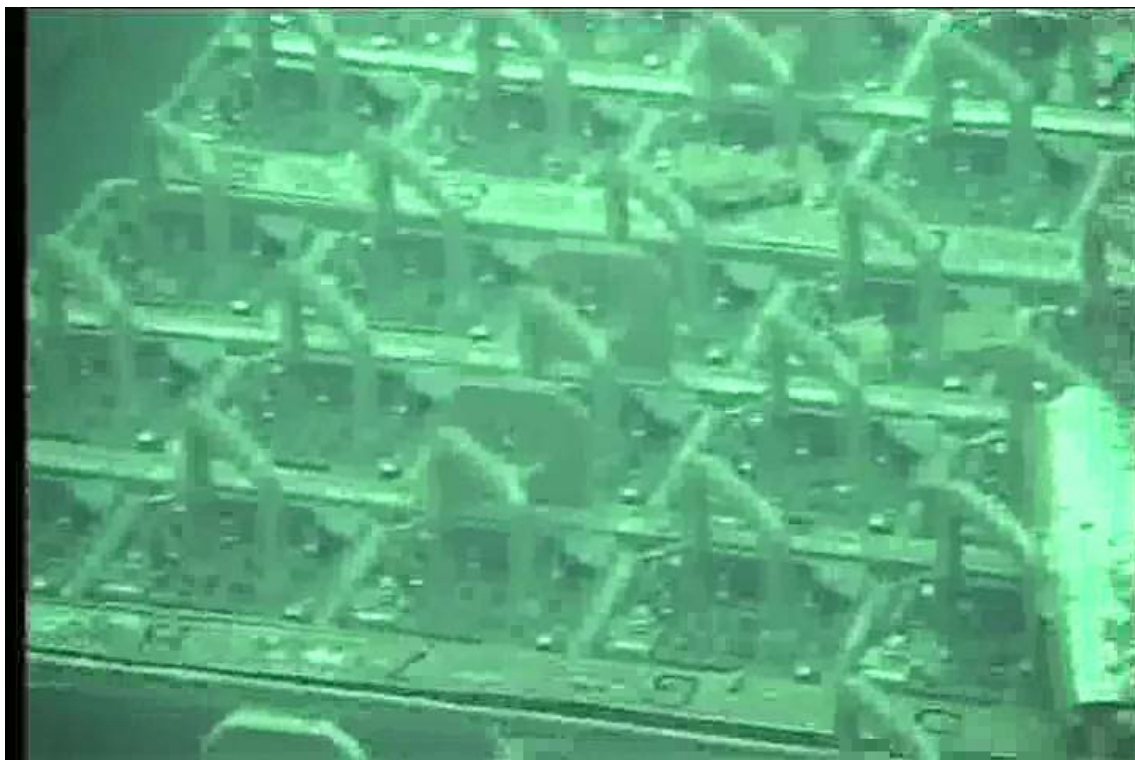
Figure II-2-49 Unit 4 Pool Viewed from Underwater (No. 4)

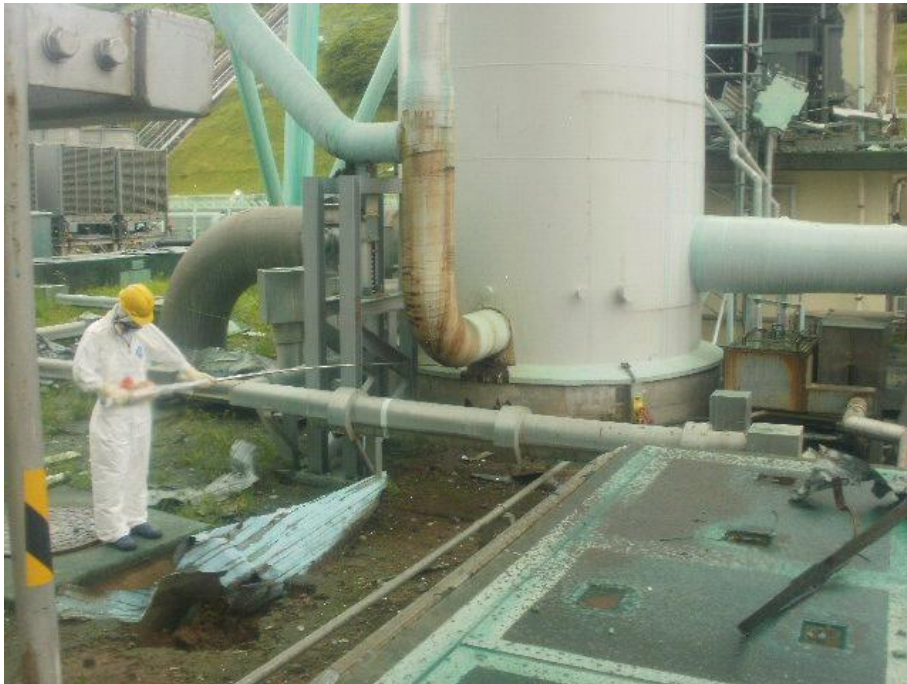
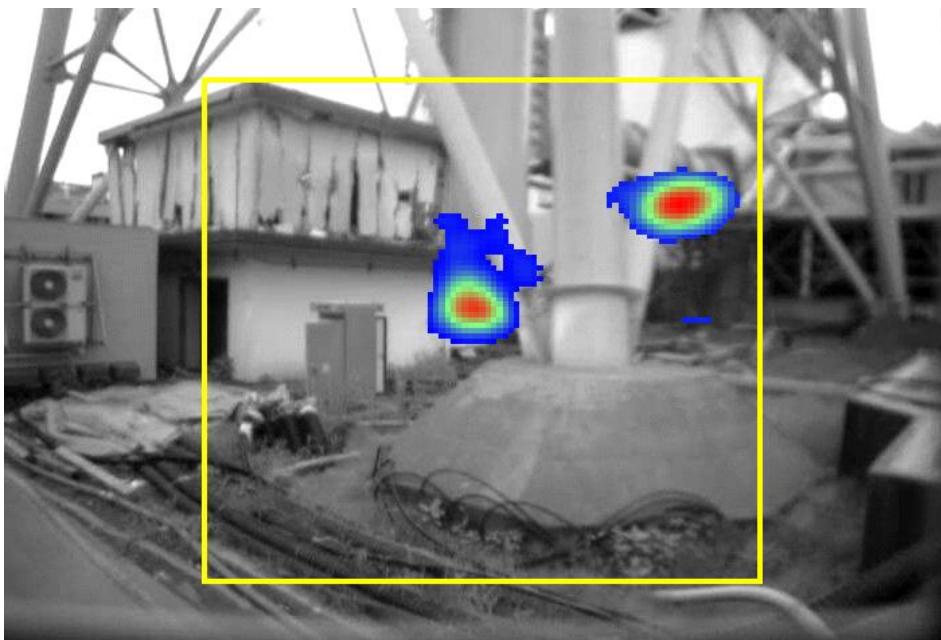
Figure II-2-60 Near the Main Exhaust Stack of Units 1 and 2 in Fukushima Dai-ichi  
NPS

Location: Near the standby gas treatment system pipe joint at the bottom of the main exhaust stack of Units 1 and 2  
Time: August 1, 2011, around 14:30  
Photographed by: TEPCO

Location: Near the main exhaust stack of Units 1 and 2  
Time: July 31, 2011, around 16:00  
Photographed by: TEPCO

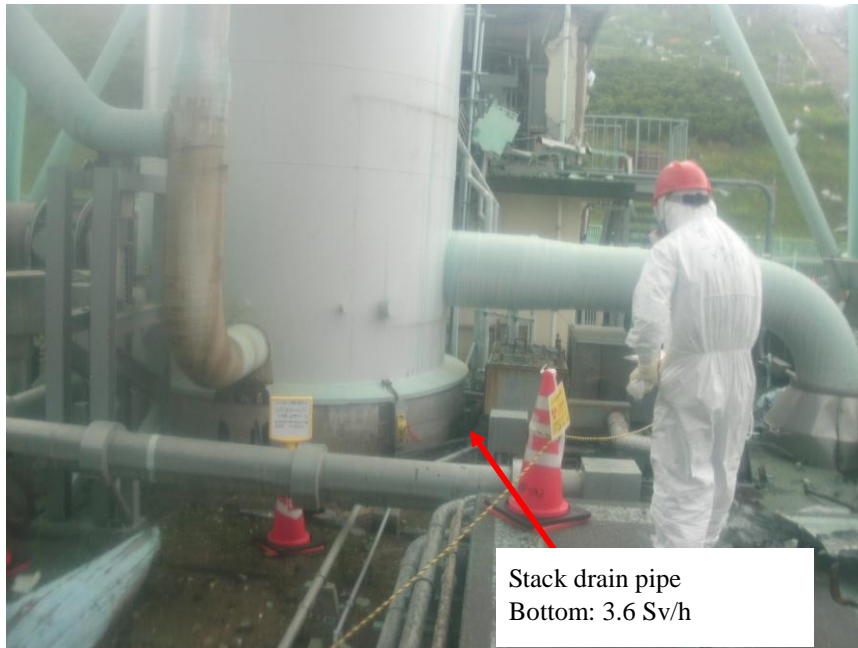
Figure II-2-62 Stack Drain Pipe of the Main Exhaust Stack of Units 1 and 2 in Fukushima Dai-ichi NPS

Location: Stack drain pipe at the main exhaust stack of Units 1 and 2 (view from the east side)

Location: Stack drain pipe at the main exhaust stack of Units 1 and 2 (view from the west side)

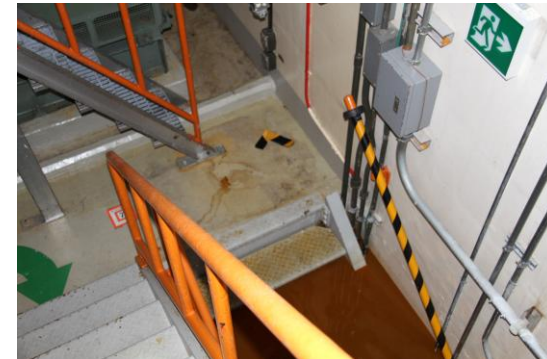
Figure II-2-63 Result of Investigation inside Unit 2 Reactor Building in Fukushima Dai-ichi NPS (No. 1)

Northwest stairs (half basement)

Southeast stairs (half basement)

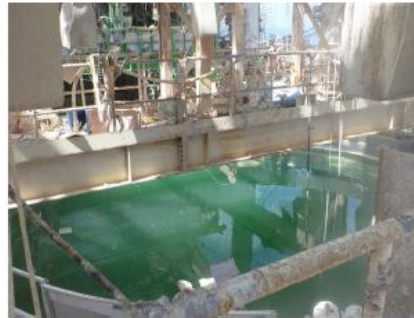
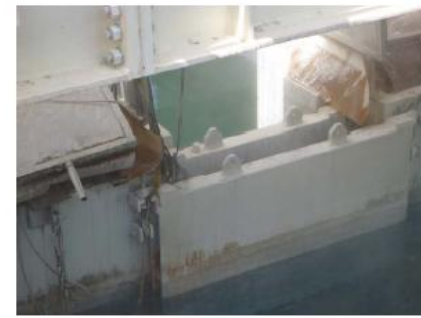
Figure II-2-69 Result of On-the-spot Investigation of the 5th Floor of Unit 4 Reactor Building in Fukushima Dai-ichi NPS

Equipment storage pool viewed from refueling carriage

Reactor well

Spent fuel pool gate

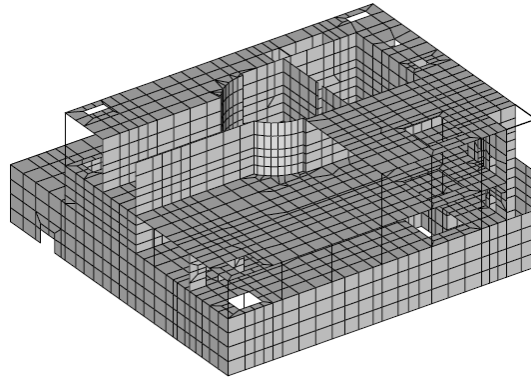
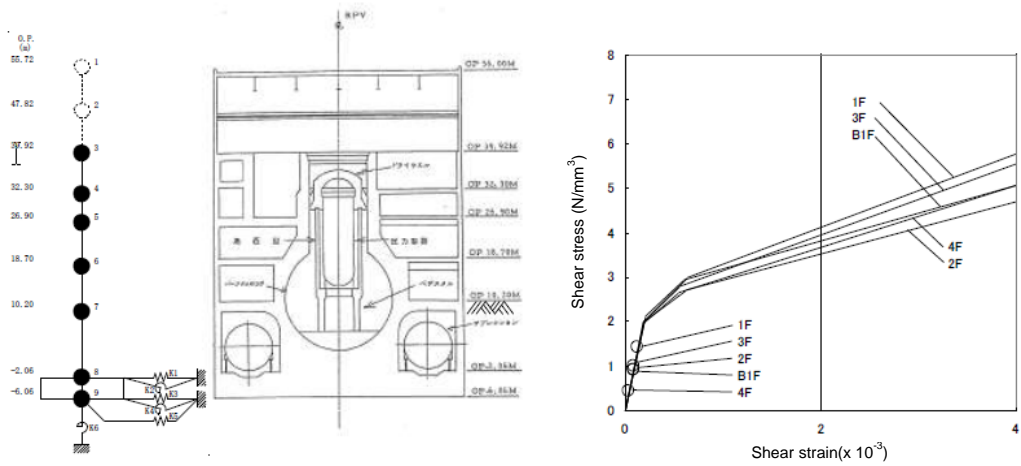
Fig. II-2-79 Lumped Mass Model and Maximum Shear Strain in the Seismic Wall for Unit 3 (TEPCO Report, July 13)

As for the Unit 3 reactor building, the structures above the operating floor (the fifth floor level) were damaged by an incident which is believed to be a hydrogen explosion on March 14. According to available sources such as photographs and video films, a majority of the structures above the fifth floor level are in the state of a stack of iron frame and concrete structures which collapsed after the explosion. The floor at the fifth level at the northwestern corner has been damaged, causing some of the collapsed iron frame and concrete structures to pile up on the fourth floor, and many parts of the walls on the fourth level are damaged.

In consideration of the above information, modifications were made to a model (II2-6) that had been prepared for the seismic design back-check; the frame structures that remained above the operating floor and the damaged seismic walls below the operating floor were no more counted as structural components. In other words, the structures above the operating floor were removed from the model for the back-check, and modifications were made to the assumed structural performance of the structures below the operating floor by decreasing the shearing cross-sectional area and the cross-sectional secondary moment from their integrity states. In addition, the model was modified to properly represent how the weight of the structures above the operating floor is distributed on the operating floor. The model was further modified to properly represent how the weight of the collapsed northwestern corner of the operating floor, and the weights of the collapsed walls and frame structures on the fourth level, are distributed on the fourth floor.

Since no part of the building was identified to have any danger of failure in ensuring the seismic safety, TEPCO, at this moment, does not plan any urgent implementation of seismic reinforcement works, etc.

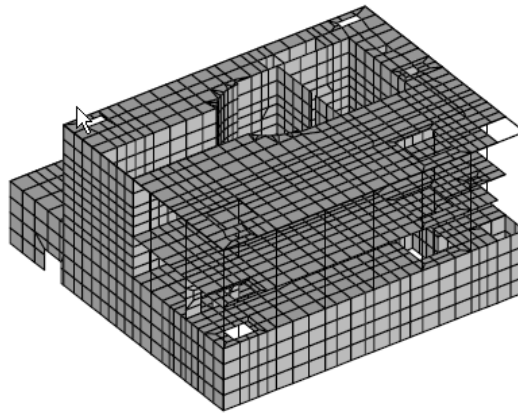
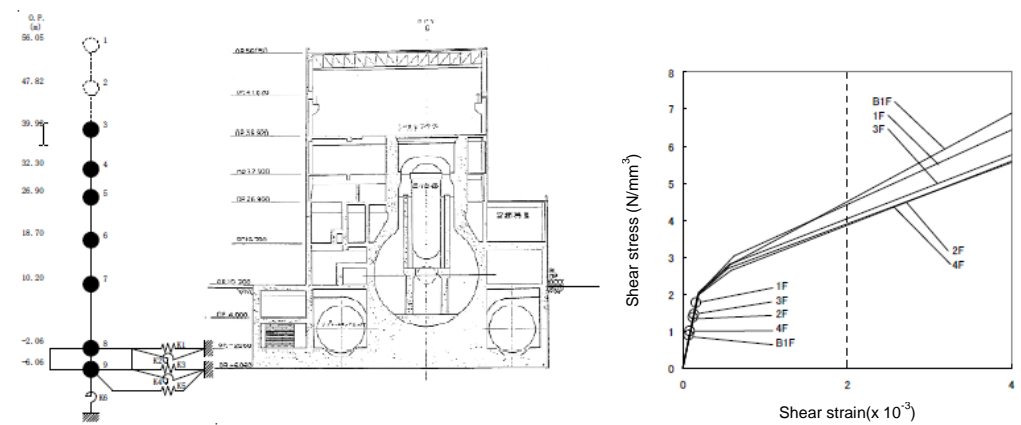
Fig. II-2-80 Lumped Mass Model and Maximum Shear Strain in the Seismic Wall for Unit 4 (TEPCO Report, May 28)

As for the Unit 4 reactor building, the building lost a majority of its roof slabs and walls above the fifth floor level due to unidentified cause on March 15, leaving only the frame structures of columns and beams, and furthermore, the available sources such as photographs and video films indicate that a majority of walls on the fourth level and some walls on the third level have also been damaged.

In consideration of the above information and also of the fact that Unit 4 was not loaded with fuel because of a scheduled outage underway on the day of the earthquake, modifications were made to a model (II2-7) for the seismic design back-check, referring to data concerning the load conditions during scheduled outages. The frame structures that remained above the operating floor and the damaged seismic walls below the operating floor were no more counted as structural components. In other words, the structures above the operating floor were removed from the model for the back-check, and modifications were made to the assumed structural performance of the structures below the operating floor. In addition, the model for the back-check was modified to properly represent how the weight of the structures above the operating floor is distributed on the operating floor.

No part of the building was identified to have any danger of failure in ensuring the seismic safety. However, since the earthquake occurred during scheduled outage, the SFP contains not only spent fuels but also all the fuel assemblies in use that otherwise would have remained inside the reactor. Even though the detailed inspection of the reactor building interior by eyesight still remains impossible, TEPCO is implementing reinforcement works (Fig. II-2-81) to SFP in order to increase the safety margin at the bottom, as the dose at some locations is low.

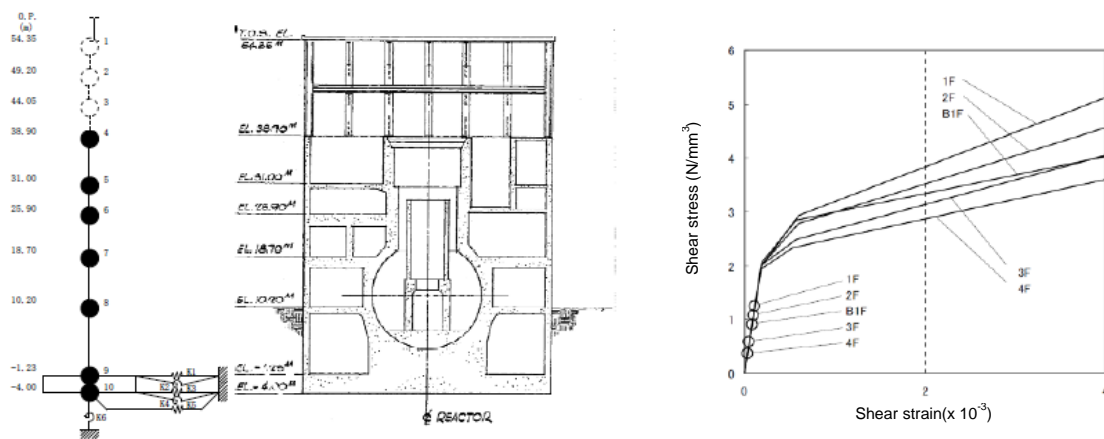
Fig.II-2-77 Lumped Mass Model and Maximum Shear Strain in the Seismic Wall for Unit 1 (TEPCO Report, May 28)

At the Unit 1 reactor building, the structures above the operating floor (the fifth floor level) were damaged by an event, which is believed to be a hydrogen explosion, occurring on March 12, the day after the Tohoku District - off the Pacific Ocean Earthquake.

Studying damages from the available sources of information such as photographs and video films, modifications were made to a model (II2-6) that had been prepared for the reassessment of seismic safety using the updated guide for seismic design (hereinafter referred to as “seismic design back-check”); the steel frame structures that remained above the operating floor were no more counted as structural components. In other words, the structures above the operating floor were removed from the model that had been prepared for the seismic design back-check. In addition, the model that had been prepared for the back-check was modified to properly represent how the weight of the structures above the operating floor is distributed on the operating floor. Components such as seismic walls and floors below the operating floor were assumed as unaffected by the explosion, thus the structural performance of the back-check model was assumed to remain unchanged.

Since no part of the building was identified to have any danger of failure in ensuring the seismic safety, TEPCO, at this moment, does not plan any urgent implementation of seismic reinforcement works, etc.

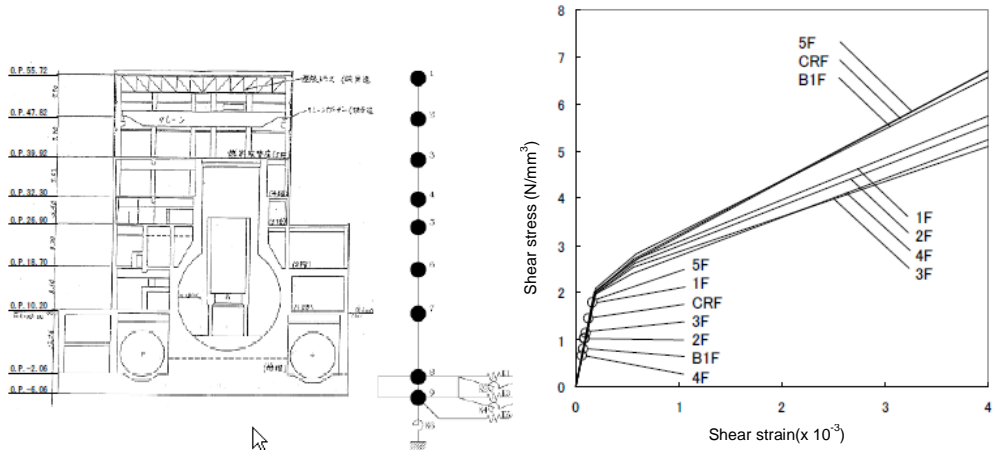
Fig. II-2-78 Lumped Mass Model and Maximum Shear Strain in the Seismic Wall for Unit 2 (TEPCO Report, August 26)

The Unit 2 reactor building shows no apparent damage even though the blow out panel on the east end external wall is exposed. Access is restricted due to high dose level, hindering the inspection of building interior, but at this moment, it is believed that there is no damage.

For more assurance, parameter studies were conducted considering the possibility of the shell wall stiffness having been reduced by a temporary rise of temperature inside the PCV and the identified noise on March 15 near the S/C at the underground level. The modifications to parameters caused some changes to the numerical outputs but did not significantly impact the analysis results.

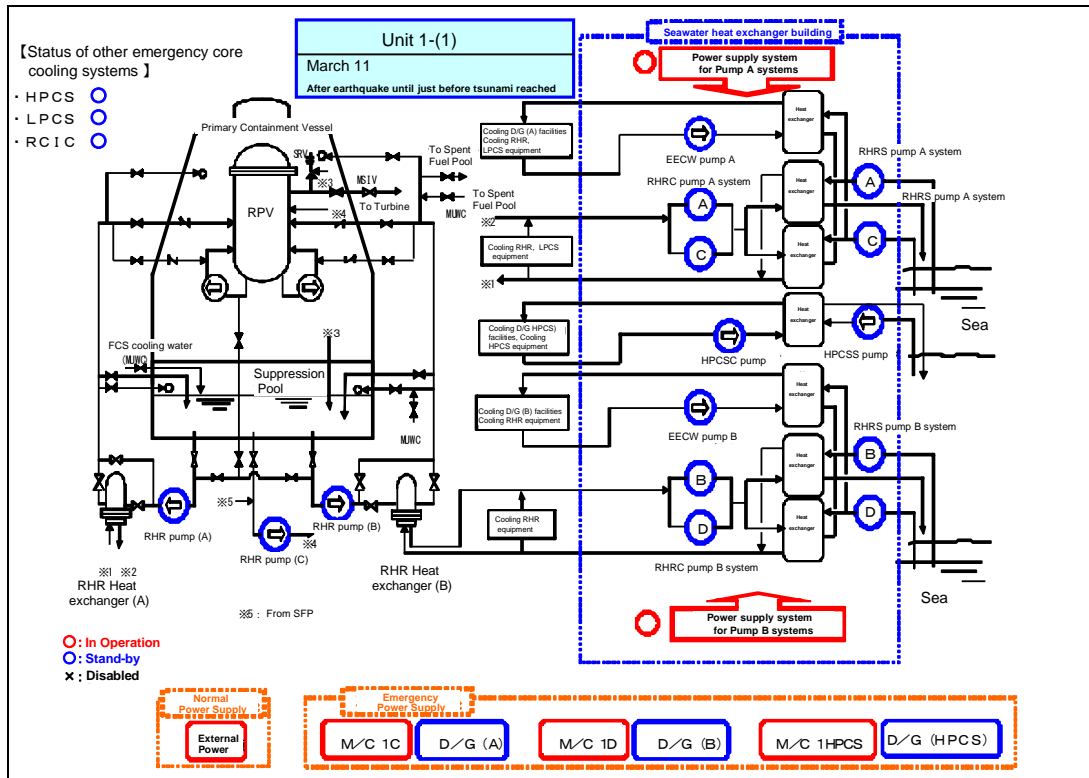
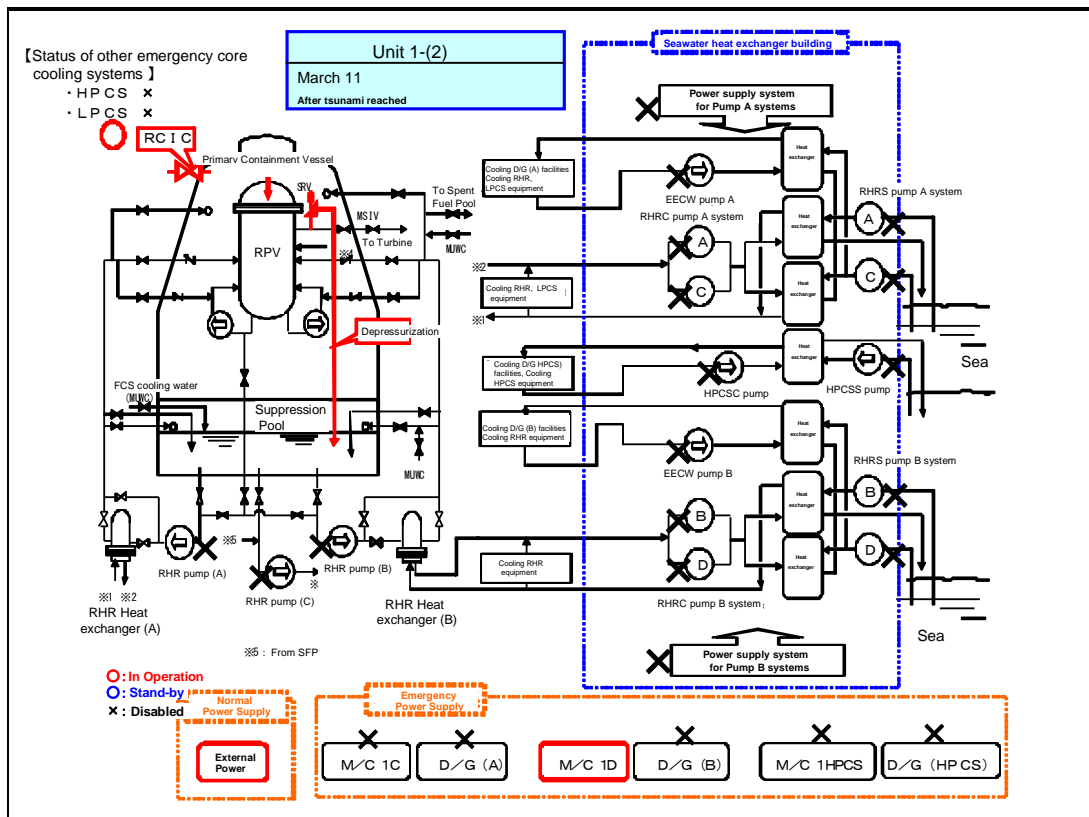
Figure II-2-107 Schematic Diagram of Station Status [2F-1] (Part 1)

Because the seawater heat exchanger building was submerged by the tsunamis, it was judged that all the pumps of emergency equipment cooling systems (residual heat removal cooling system (RHRC), RHRS, emergency equipment cooling water system (EECW), high pressure core spray cooling water system (HPCSC) and high pressure core system cooling seawater system (HPCSS)) failed to be actuated (later, it was confirmed at the site that some motors and emergency power supply systems (P/C 1C-2 and 1D-2) became inoperable because they had been inundated). As a

result, all the ECCS pumps failed to be actuated, and the function to remove residual heat from the reactor was lost, and hence the decay heat could not be transferred to the sea, which had been the ultimate heat sink. Under such circumstances, at 18:33 on March 11, TEPCO judged that the situation corresponded to the “loss of reactor heat removal function” event in accordance with Article 10 of the Special Law of Emergency Preparedness for Nuclear Disaster.

“Drywell pressure high” (set value: 13.7kPa gage) alarm was issued at 17:35 on March 11, because the RHR pump failed to cool down the PCV in which temperature and pressure rose due to operation of the RCIC and the SRV. In response to the alarm, automatic actuation signals of all the ECCS pumps were generated. However, the LPCS pump, RHR pump (A) and HPCS pump did not actuate automatically because the emergency power source units (M/C 1C and 1HPCS) were inoperable. The RHR pumps (B and C) were manually stopped because the RHRC pumps (B and D), RHRS pumps (B and D) and EECW pump (B) were inoperable. At this point, measures were taken to prevent further automatic actuation.

In parallel with these attempts for cooling the reactor, RHRC pump (D), RHRS pump (B) and EECW pump (B) were inspected and repaired (motors were replaced for RHRC pump (D) and EECW pump (B)). As the seawater heat exchanger building of Unit 1 was submerged and the emergency power supply units (P/C 1C-2 and 1D-2) were inundated, temporary cables, which were urgently procured from outside the NPS, were installed to receive electricity from the power supply unit (P/C 1WB-1) of the radioactive waste treatment building, supplied by the external power system, and also from high voltage power supply vehicles, which were also procured from an off-site organization. In this way, electricity was supplied to RHRC pump (D), RHRS pump (B) and EECW pump (B) through the temporary cables, and these pumps were restored and actuated one after another from 20:17 on March 13 onward.

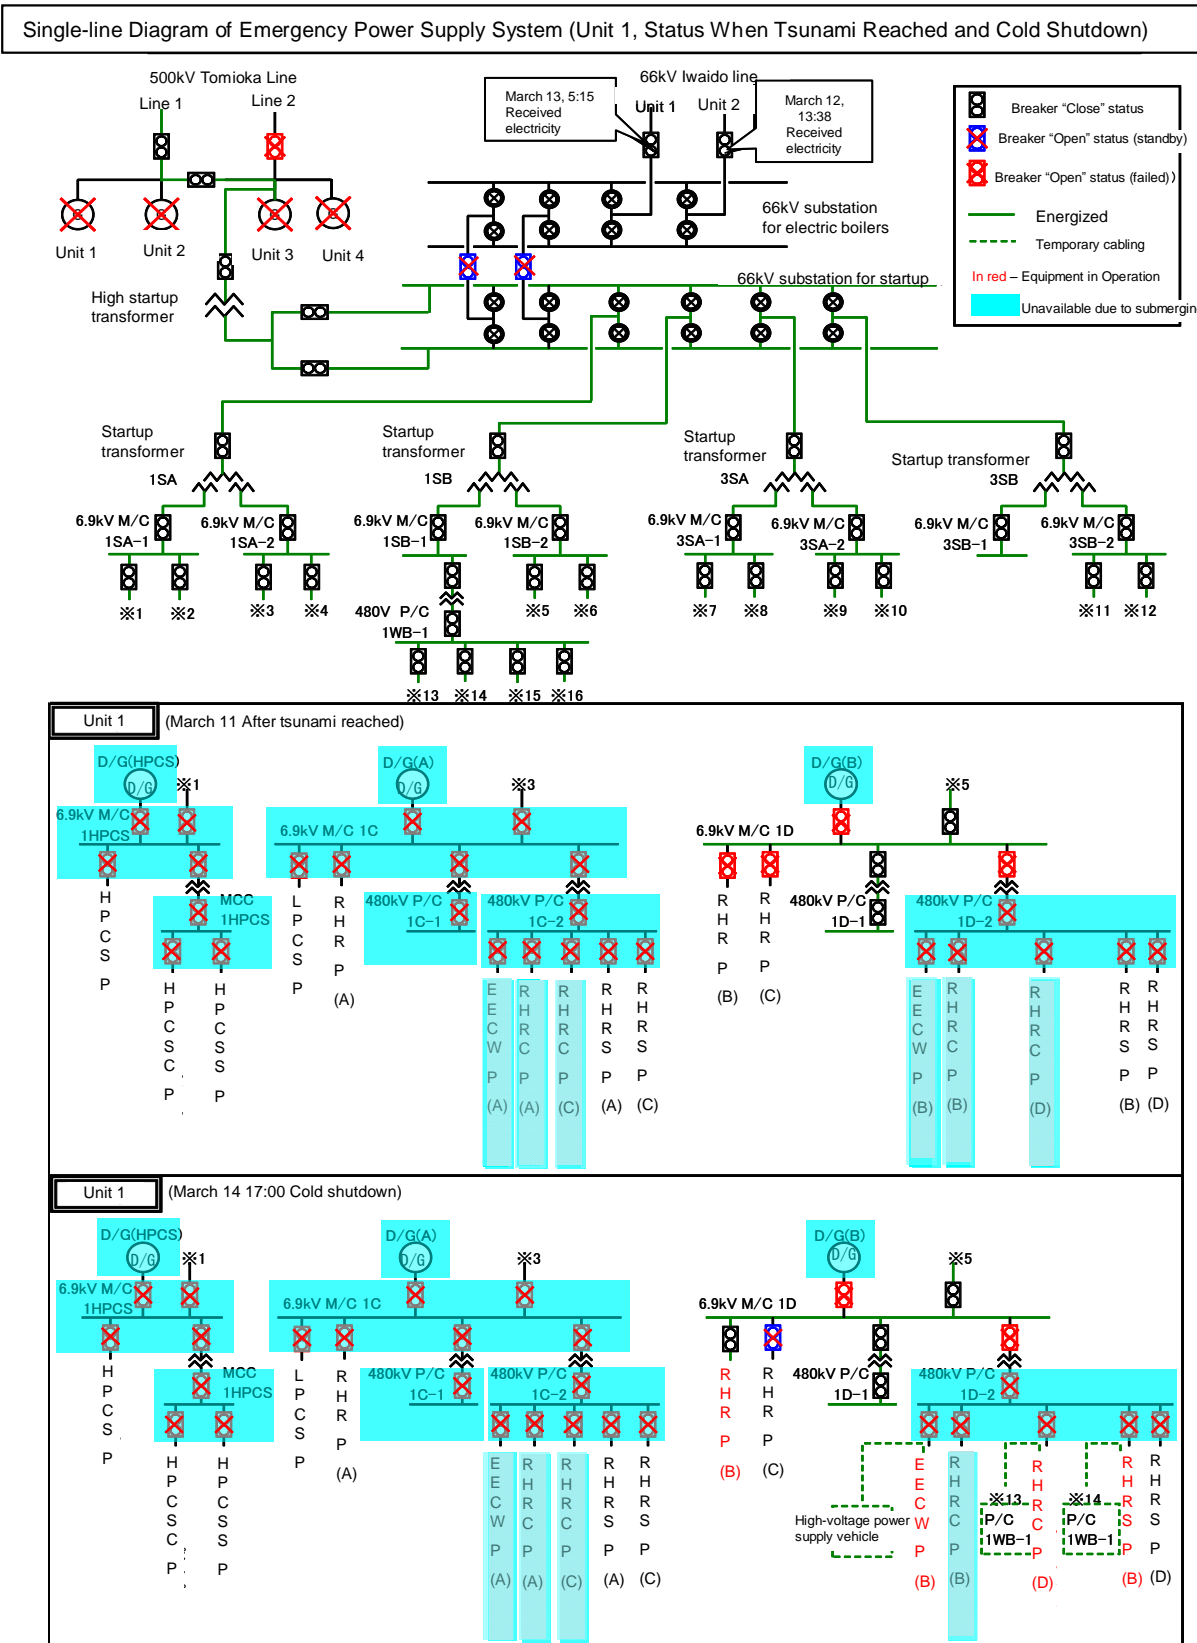
Figure II-2-109 Status of Single-line Diagram of Emergency Power Supply System [2F-1]

Emergency DGs (A and B systems, and HPCS system) were all operable immediately after the reactor scram. However, after the tsunami strike, all the emergency equipment cooling water system pumps failed to be actuated. Furthermore, as the reactor building annex was submerged due to tsunamis, the main bodies of the emergency DGs and their accessories (such as pumps, control panels, MCCs) were inundated, and thus all the emergency DGs became inoperable.
