Additional Report of the Japanese Government  
to the IAEA

- The Accident at TEPCO's Fukushima Nuclear Power Stations -  
(Second Report)

September 2011

Nuclear Emergency Response Headquarters  
Government of Japan

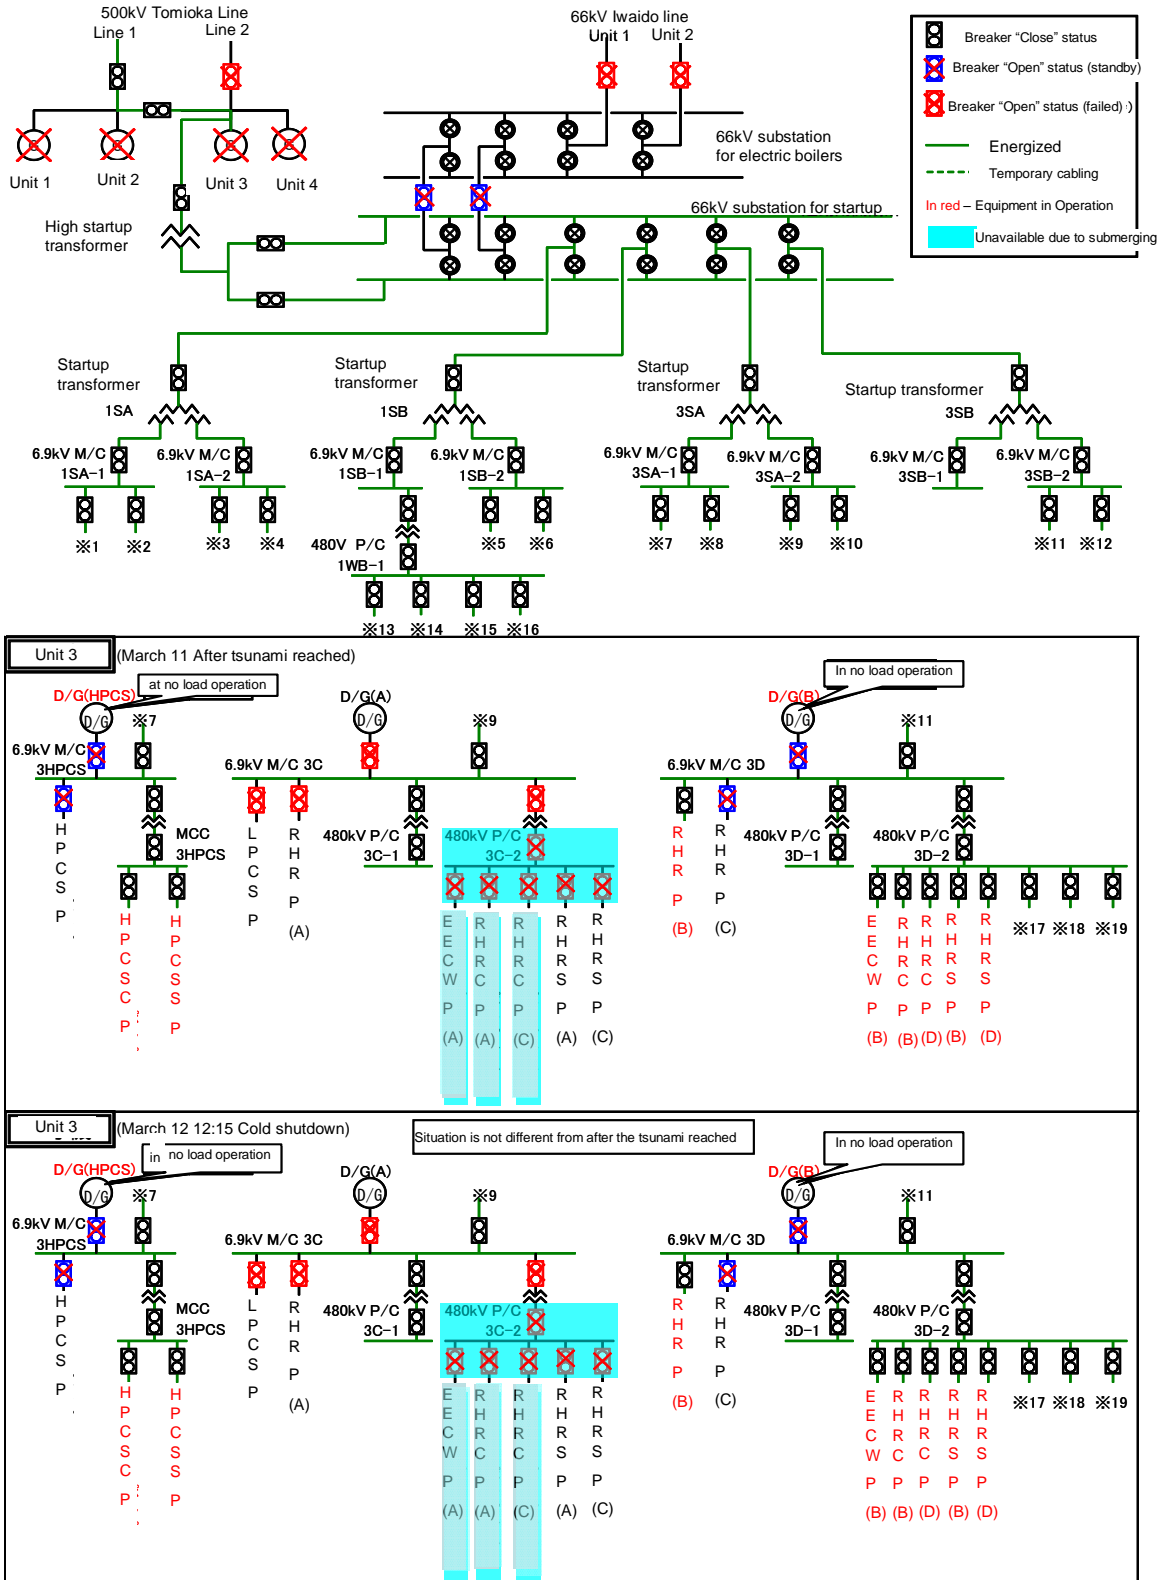
Figure II-2-119 Status of Single-line Diagram of Emergency Power Supply System [2F-3]

Single-line Diagram of Emergency Power Supply System (Unit 3, Status When Tsunami Reached and Cold Shutdown)

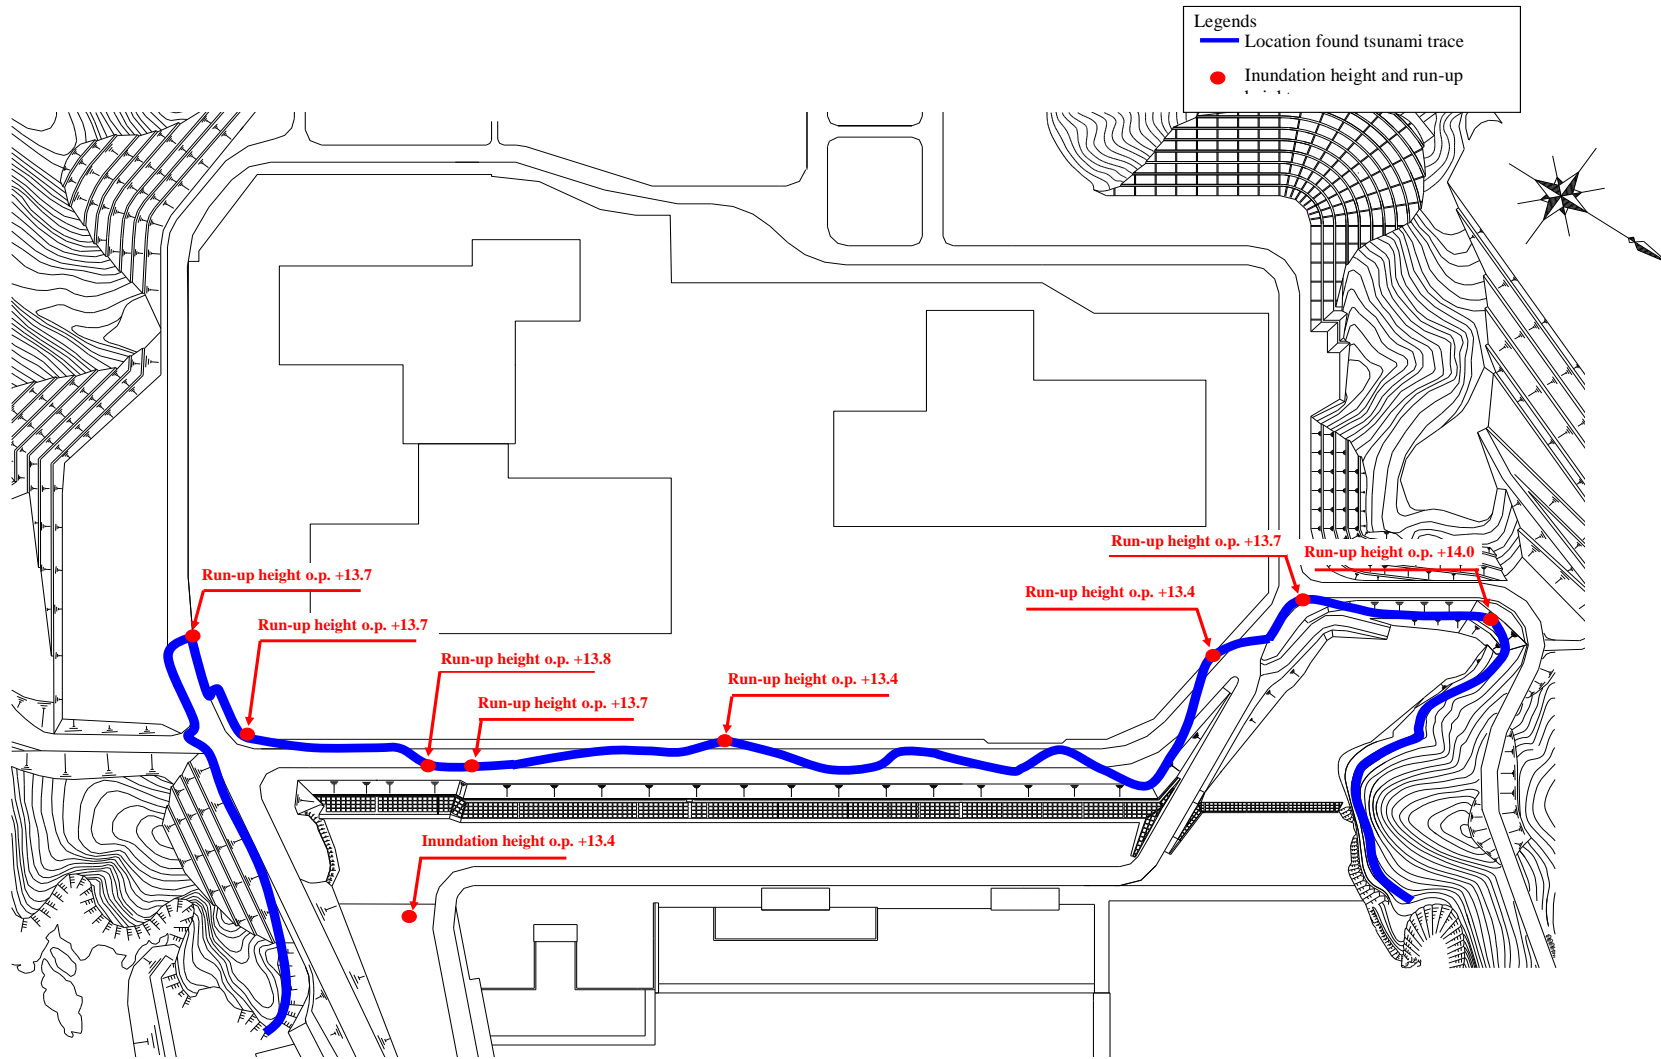
Figure II-2-131 Tsunami Run-up Height and the Location Found Run-up Trace in Onagawa NPS

At the Onagawa NPS, the maximum water level of tide gauge (O.P. (Onahama port base tide level for construction) + about 13 m\*) was observed at approximately 15:29, about 40 minutes after the mainshock occurred. Also, the maximum height of the run-up of the tsunami in front of the site where the main building is located was O.P. + about 13.8 m\*, but the ground level of the NPS site was about 13.8 m\* so that it did not result in being submerged or flooded.

Regarding Unit 1, no impact of the tsunami was found on emergency facilities, including the emergency component cooling water system, but it was found that a heavy oil tank for the boiler (HB) supplying steam used for heating in the NPS building and sealed steam used for the turbine shaft seal part at the startup of the plant was collapsed.

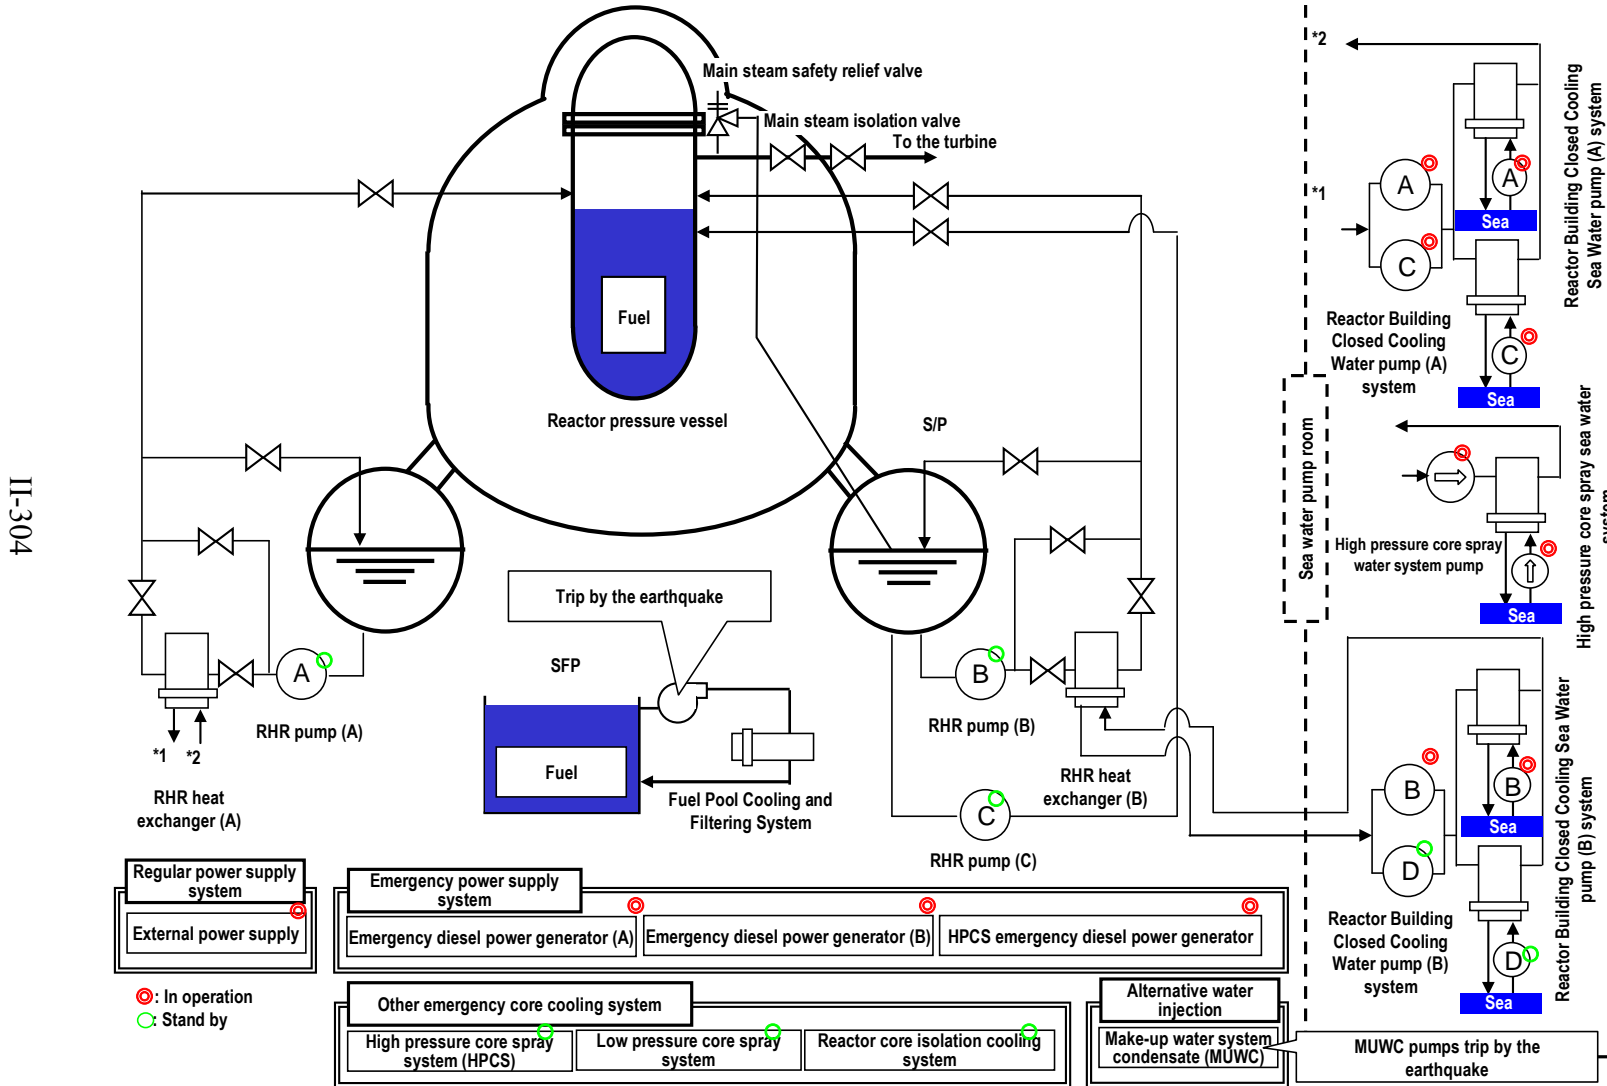
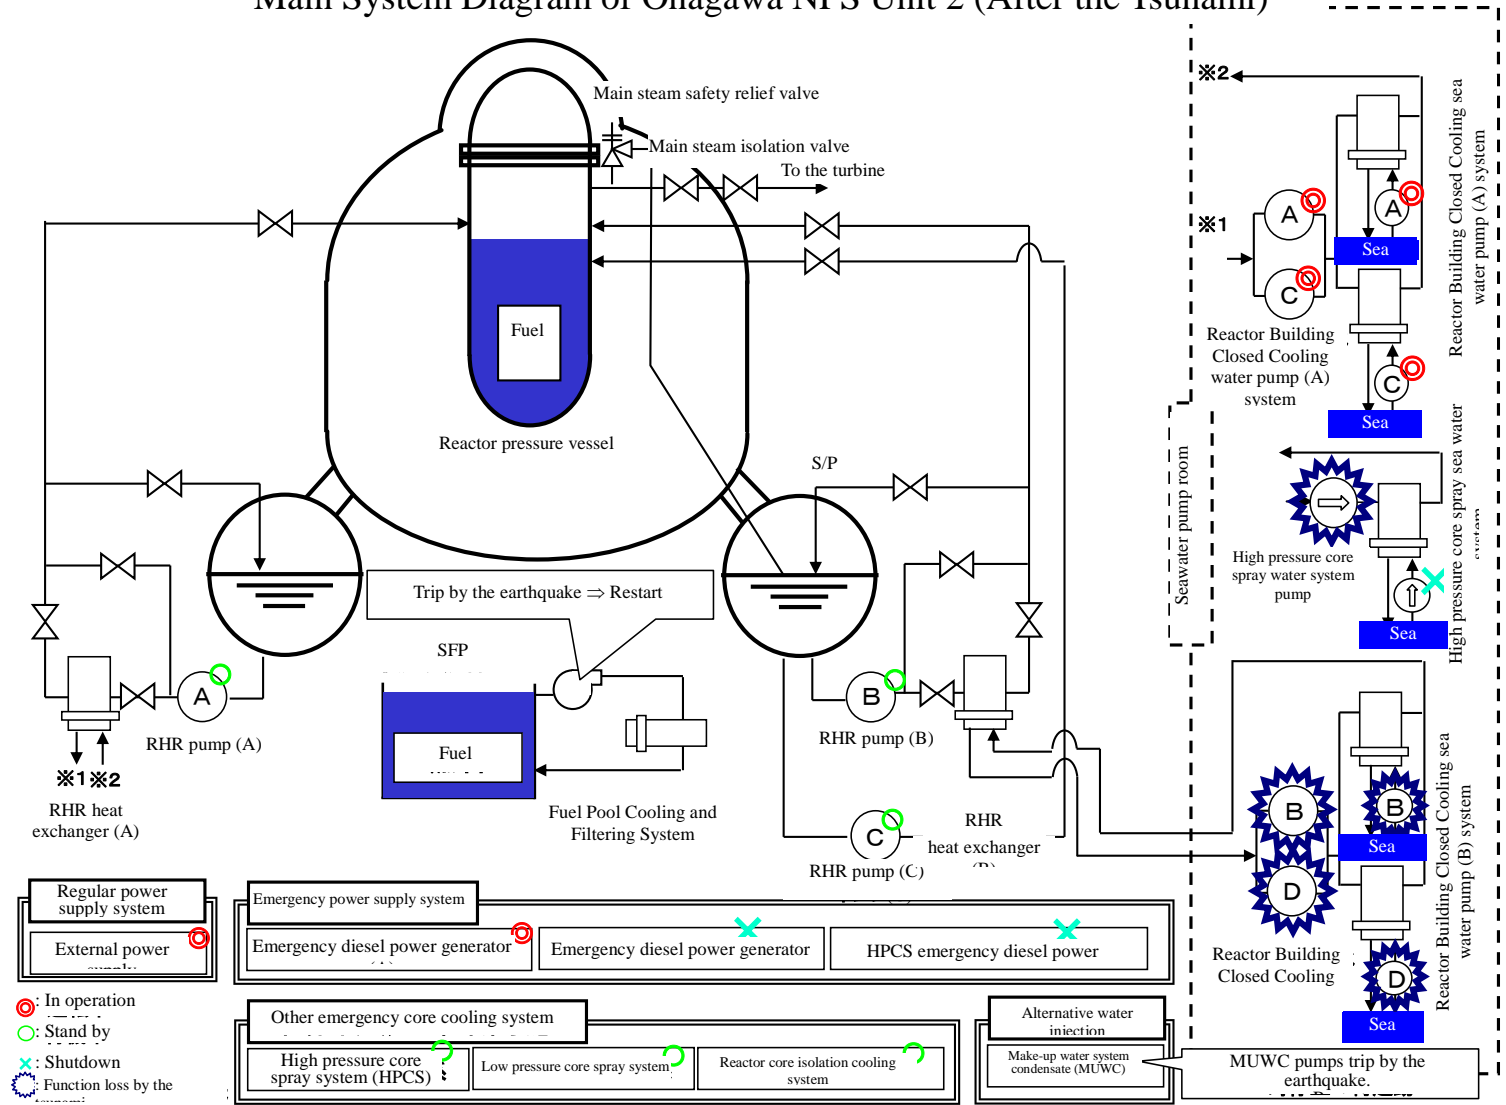
Figure II-2-132 Change in the Main System Affected by the Tsunami (Part 1)

In this situation, although RCW (B) lost its functions due to inundation within a portion of the inside of the reactor building on account of the tsunami, since RCW (A) was robust, the FPC caused no effect on the cooling function of the SFP.

14:49 Reactor mode switch: “Start-up”→“Shut-down” (The reactor condition was “cold shutdown.”)
	15:34 RCW pump (B) automatic trip. (Because the pump is submerged.) RCW pump (D) automatic start up and then automatic trip immediately. (Because the pump was submerged.)

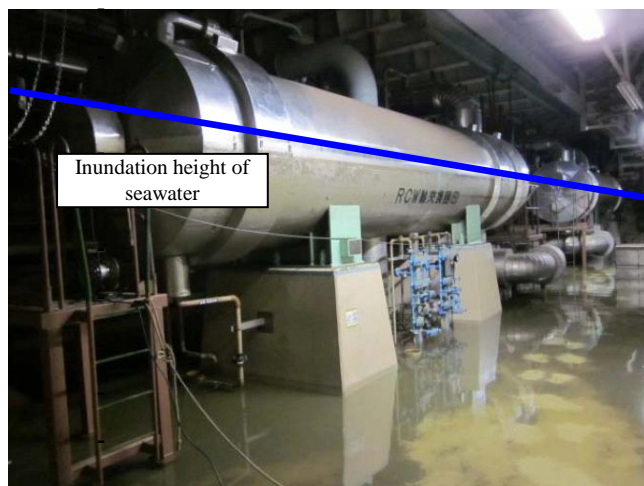
The depth of water was confirmed to have been 2.5m, based on traces found in the relevant area.

Seawater flooding in the RCW heat exchanger chamber B

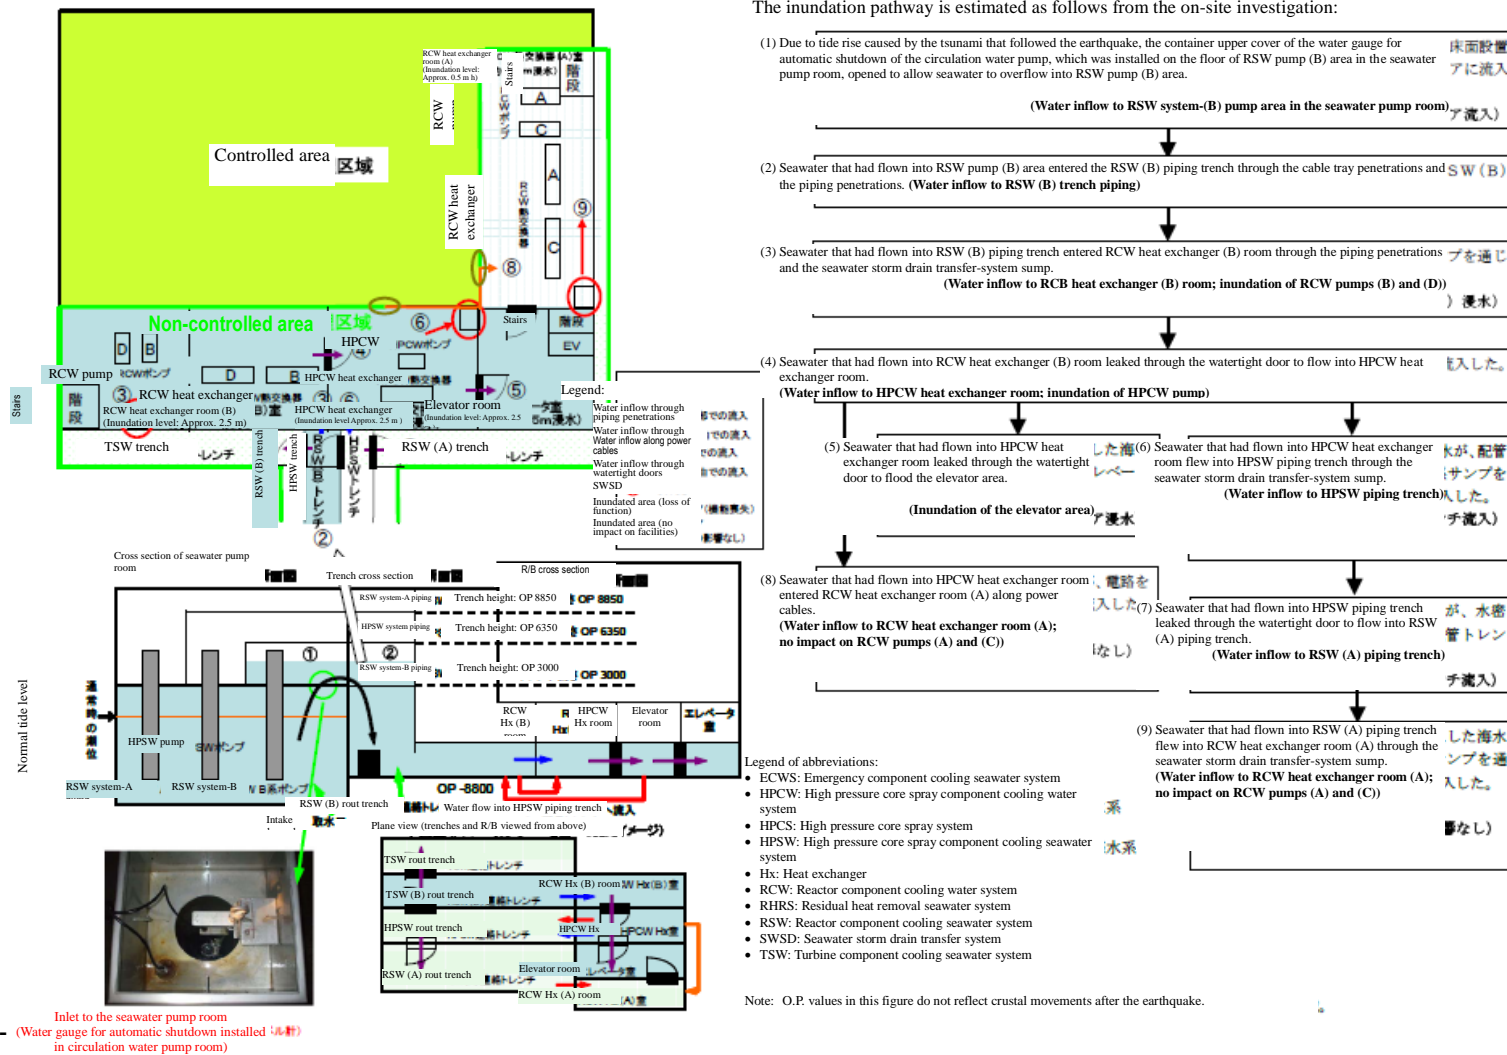
- Fig. II-2-144 Estimated mechanism of flooding

Inlet to the seawater pump room  
 - (Water gauge for automatic shutdown installed in circulation water pump room)

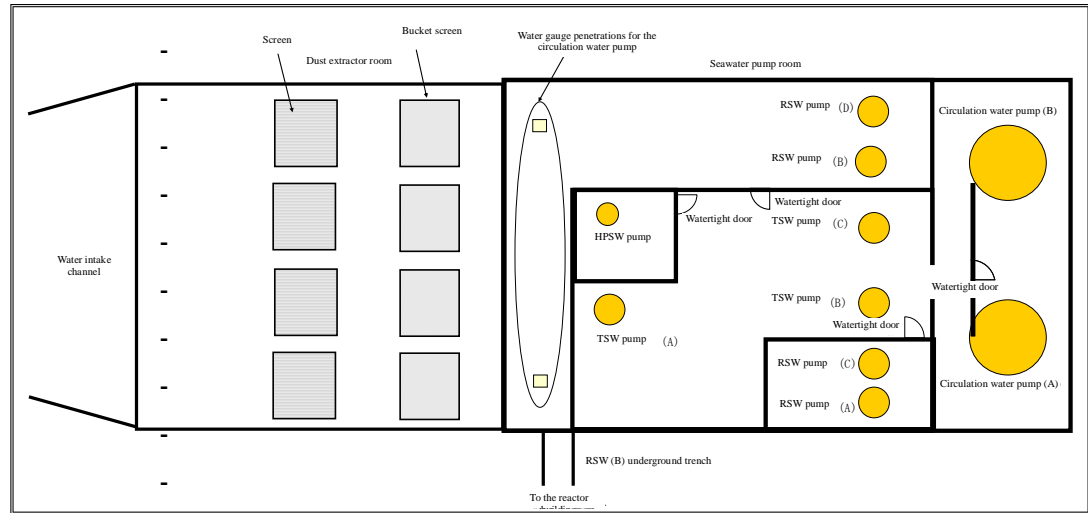
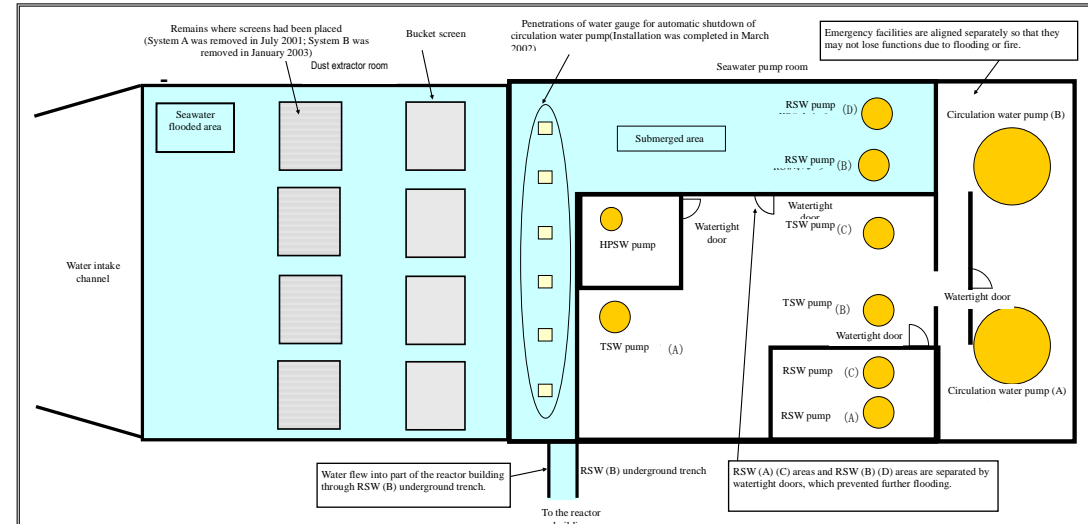
Fig. II-2-145 History of the installation of water gauge for the circulation water pump

Figure II-2-145 shows the installation conditions of the relevant water-level detector.

History	
1994 - 1996	<p>In the safety review of Onagawa Unit 3, it was decided that automatic shutdown circuits that works with a decrease in the tide level should be installed to protect CWP during backwash of tsunami attacks.</p> <p>It was also decided to install similar circuits at Onagawa Unit 2. The design work was started.</p>
May, 2000	<p>The additional installation of automatic shutdown circuits to CWP at Onagawa Unit 2 started.</p> <p>Six installation areas were selected in consideration of sufficient spaces: two places of existing water gauges in the area of RSW pumps (B) and (D) and four other places adjacent to them.</p>
March, 2002	<p>The additional installation of automatic shutdown circuits to CWP at Onagawa Unit 2 was completed.</p>

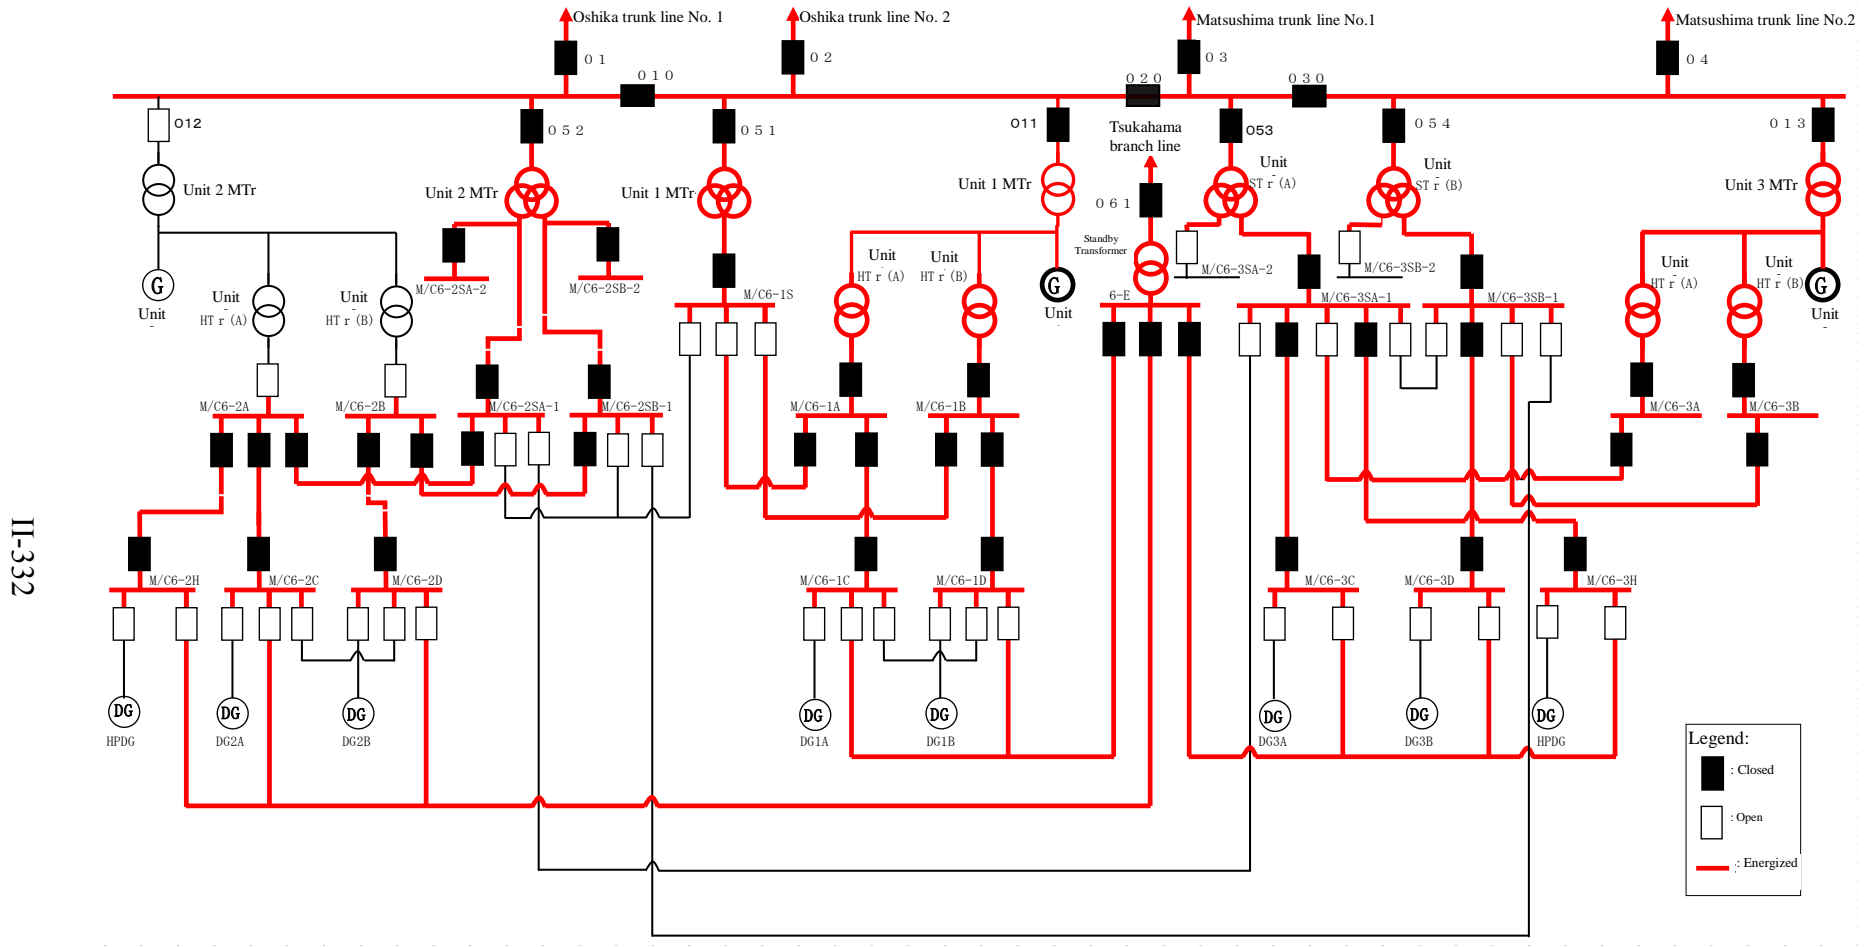
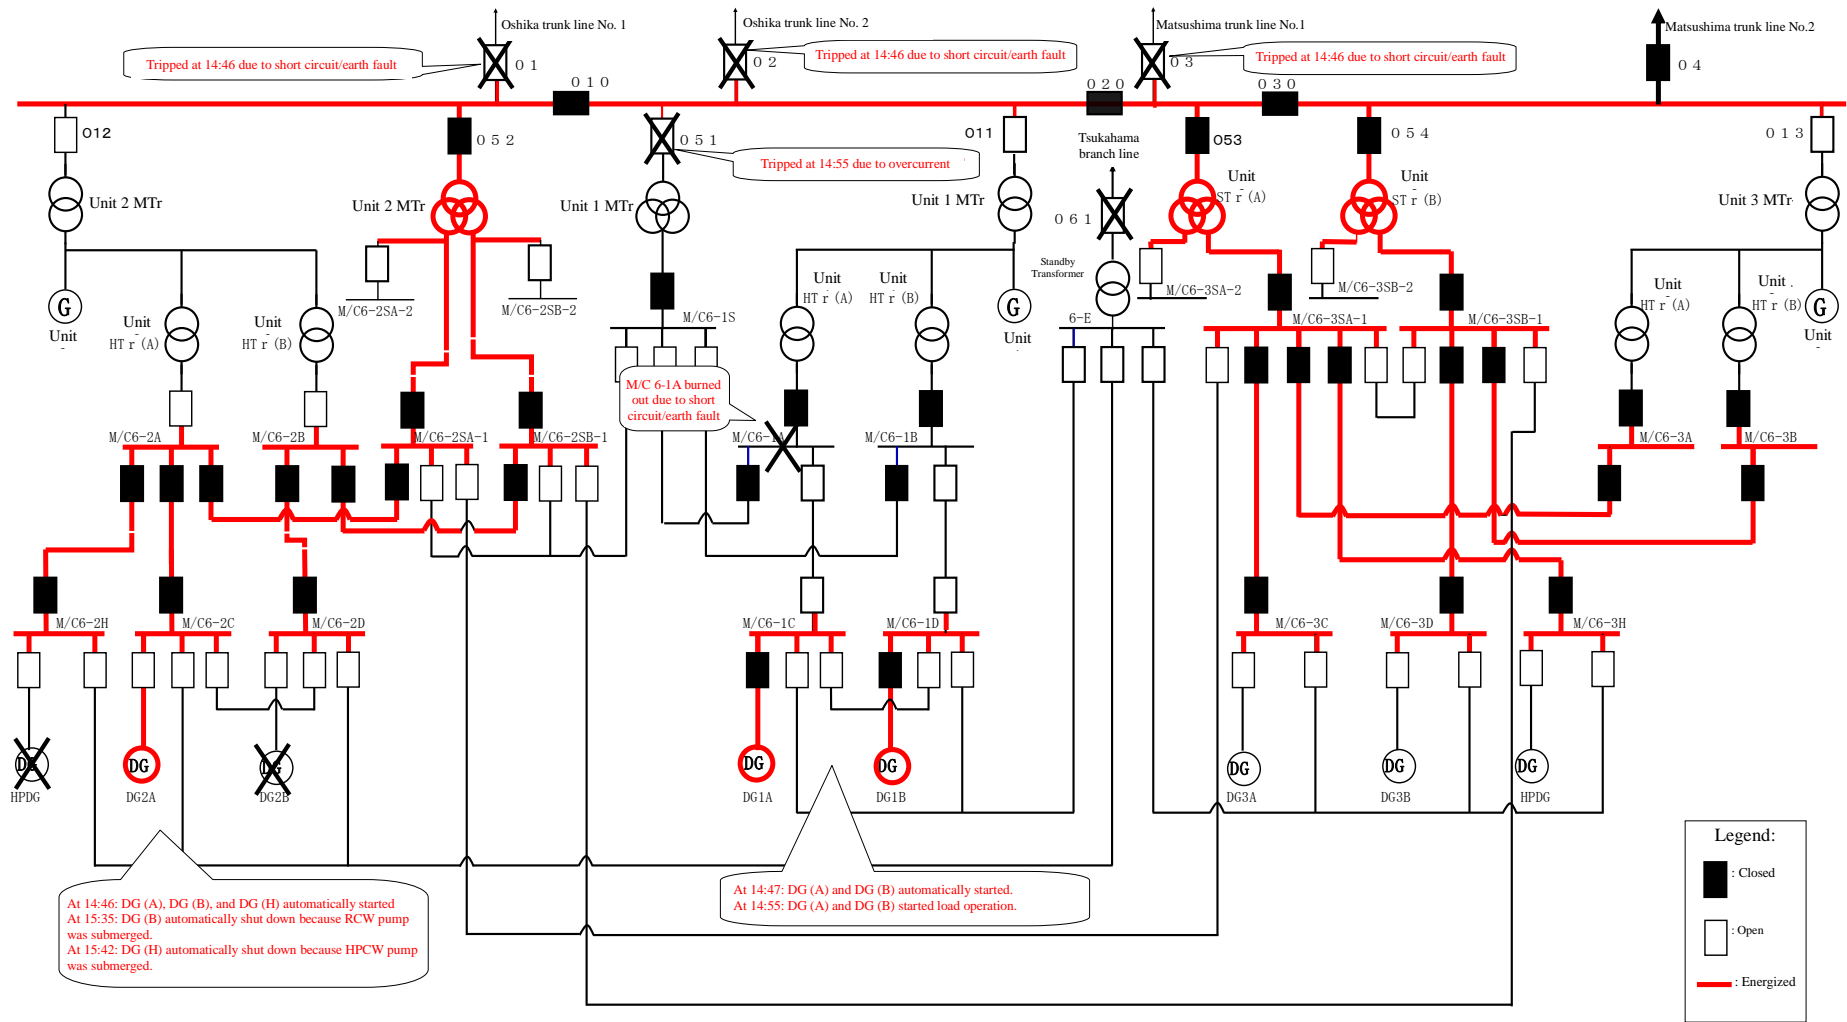
Fig. II-2-146 Power source system before and after the earthquake (before the quake)

After the earthquake, the external power supply was secured. After that, an earth fault/short-circuit in the regular high-voltage metal-clad switchgear (M/C) 6-1A occurred due to the earthquake, causing the start-up transformer to stop. Consequently, the power supply in the station failed instantaneously, but an emergency power supply was immediately secured by emergency DGs.

2:05 Since the start-up transformer received power (recovery), all normal buses except M/C 6-1A where fire occurred were re-energized.	
10:00 Reactor scram was reset.

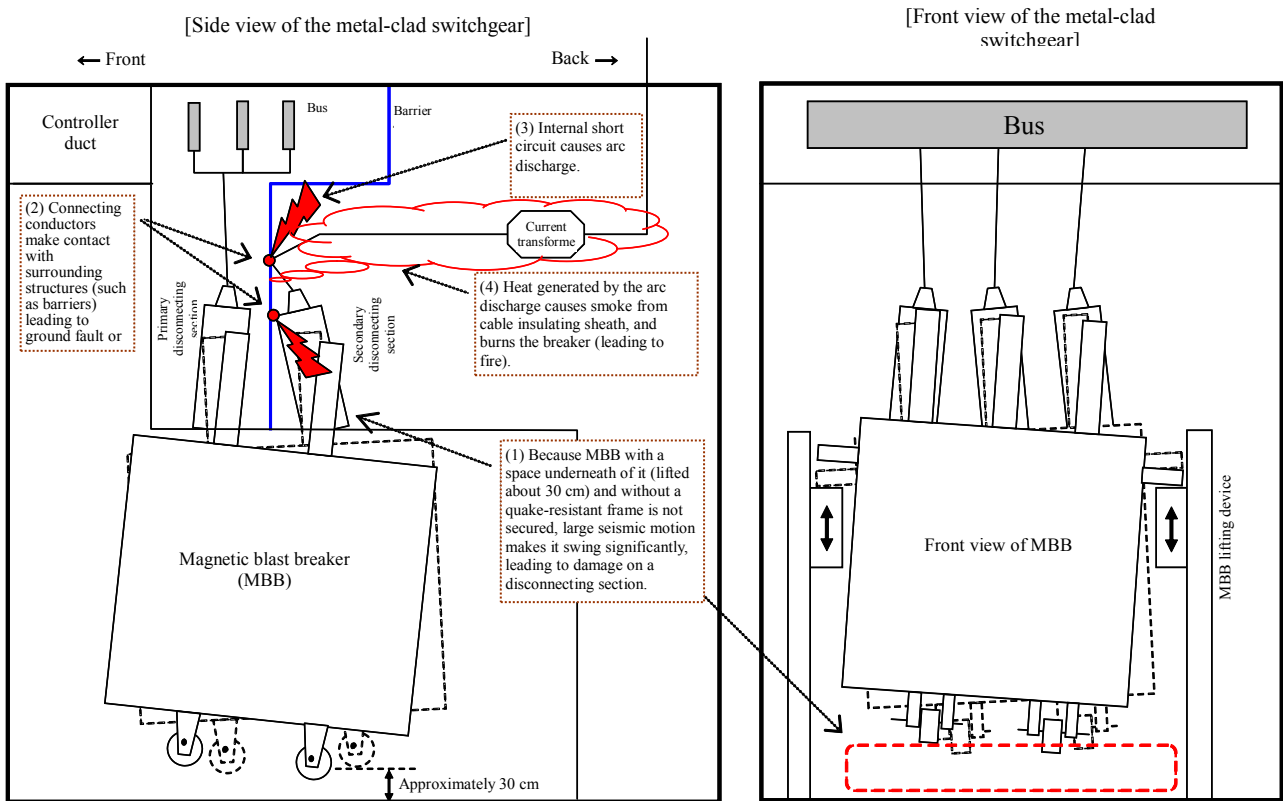
Fig. II-2-147 Estimated mechanism of the fire

**Estimated mechanism that led to the fire:**

Because the breaker unit in connecting position during operation is a vertical-type magnet blast breaker (MBB), the lifting device lifts the MBB in order to shift its position from disconnection to connection. However, the MBB is not secured because no quake-resistant frame is installed under MBB.

(The fire-fighting team of the In-house Fire Brigade did not recognize any flames at this site on the day of the fire.)

- i. In order to prevent fire, the high-voltage power panel 6-1A of the normal system in which fire broke out will be replaced with one using horizontal-type vacuum circuit breakers having a stronger anti-seismic structure.
- ii. The varistor and the rectifier with which abnormalities had been found were replaced on April 28. In addition, those emergency DG (A) and synchronoscope circuits with which ground faults had been found were isolated.

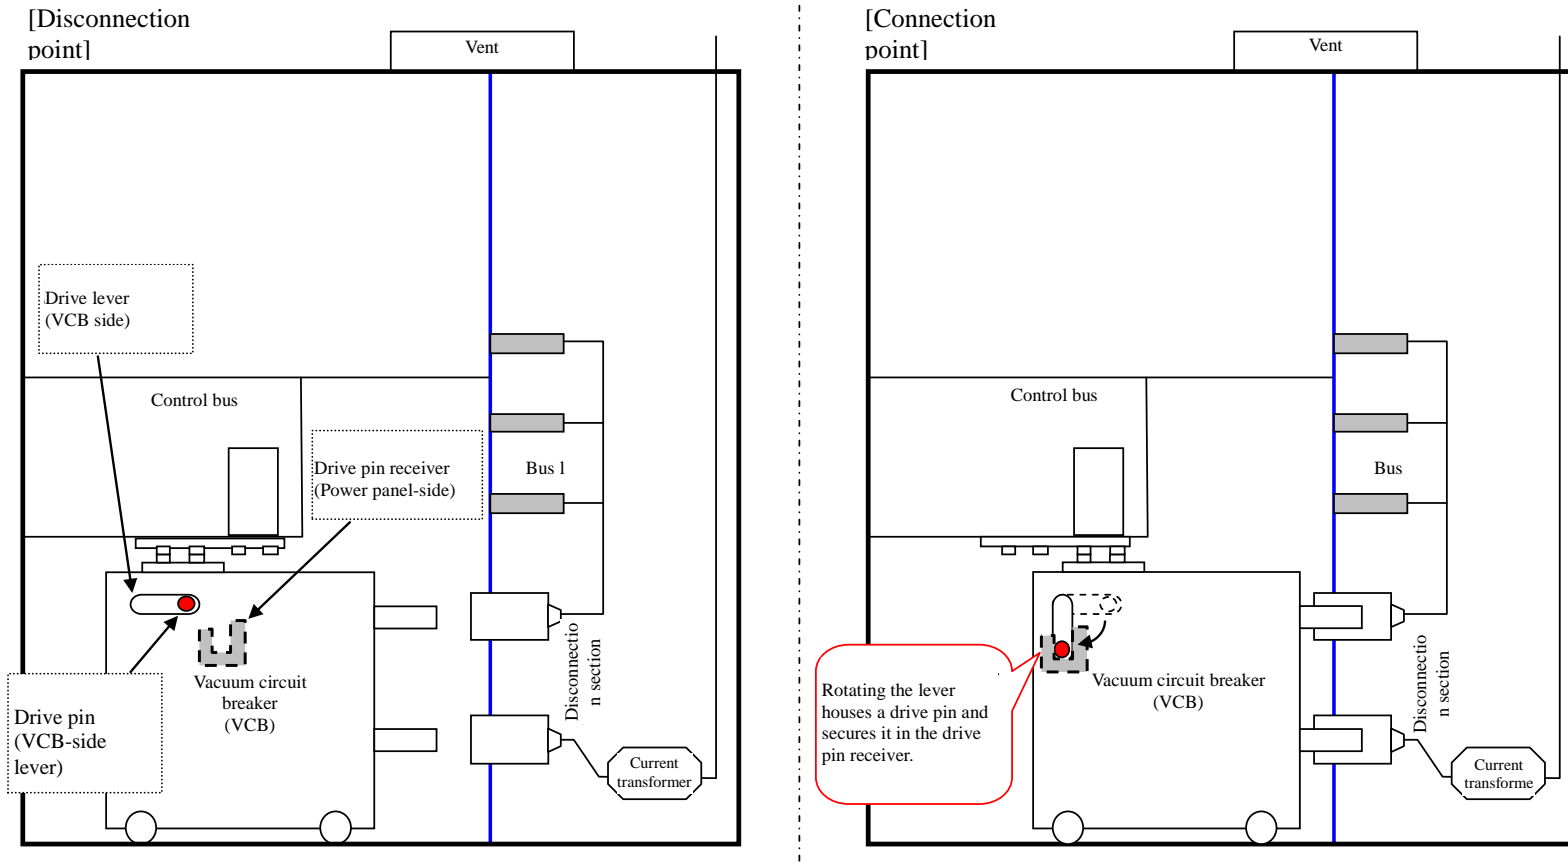
Fig. II-2-148 Vacuum circuit breaker (Schematic diagram)

High-voltage power panels using a vacuum circuit breaker (VCB) are of the horizontal type. Rotating the drive lever on the VCB side houses an attached drive pin in the drive pin receiver on the power-panel side and secures it at the connection point. It has been confirmed that this mechanism was intact even after the earthquake. Therefore, high-voltage power panels using circuit breakers of the same type as the damaged non-earthquake-resistant magnetic blast circuit breaker (MBB) will be replaced by high-voltage power panels using VCB.

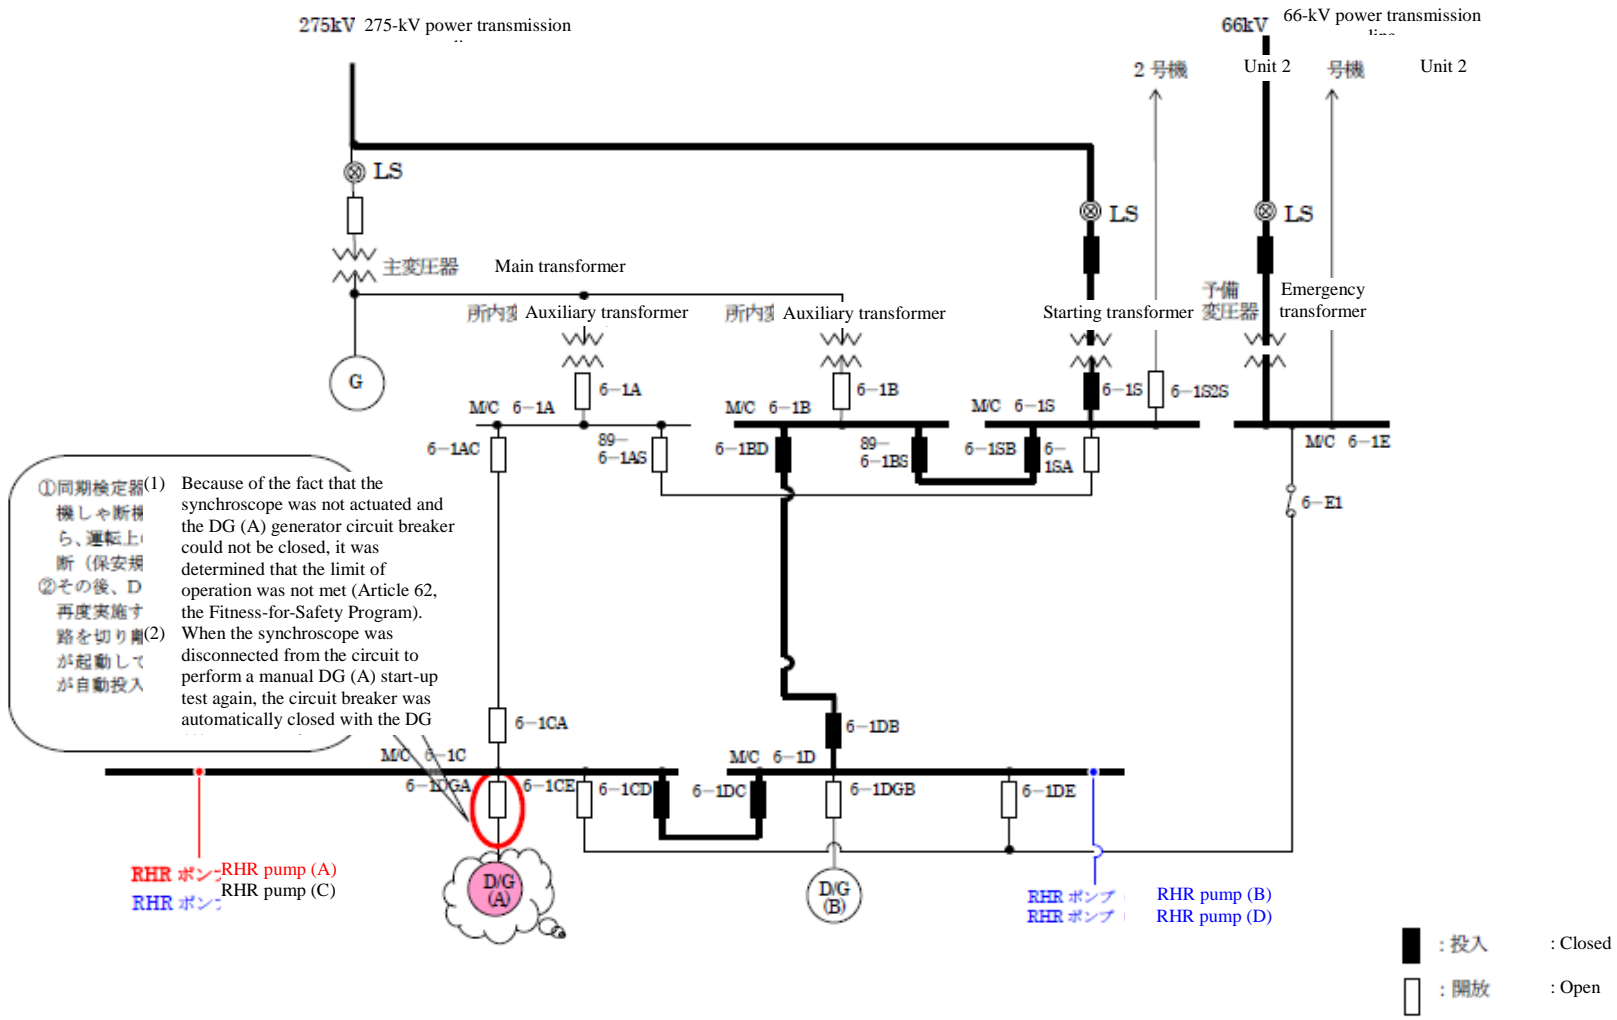
Fig. II-2-150 Onagawa Nuclear Power Station Unit 1 Schematic connection diagram for DG (A) system

Output circuits of synchronization detection relays have been designed to be separated from the normal system via relays. However, with a view to improving reliability of the emergency DGs against cables' damages and melting due to fire and other causes, output circuits of the synchronization detection relays are to be separated at all times, and switches and other devices will be installed so that connection can be established only when it is necessary to make connection for manual start-up tests of the emergency DGs.

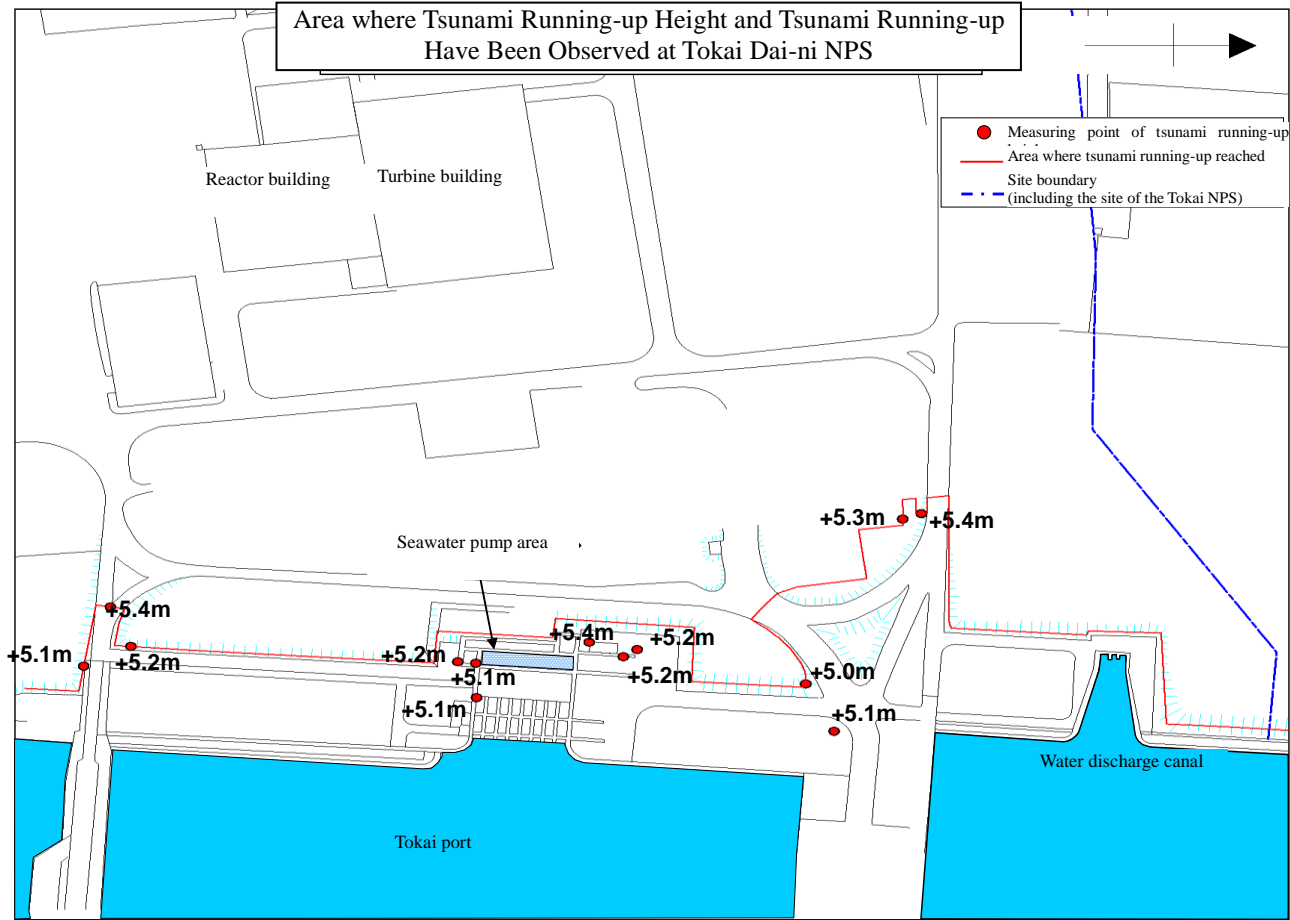
Fig. II-2-167 Tsunami Running-up Height and Area where Tsunami Running-up Have Been Observed

Figures II-2-167 and II-2-168 show the extent and height to which the tsunami reached. As a result of investigation of inundation damage at the water intake area based on the video recorded by the security camera installed in the power station, it was found that at around 15:35, the water intake area (height above sea-level (“TP”) of approx. +3.31m) was inundated up to a depth of approx. 1m (the depth of inundation estimated based on the security camera video).

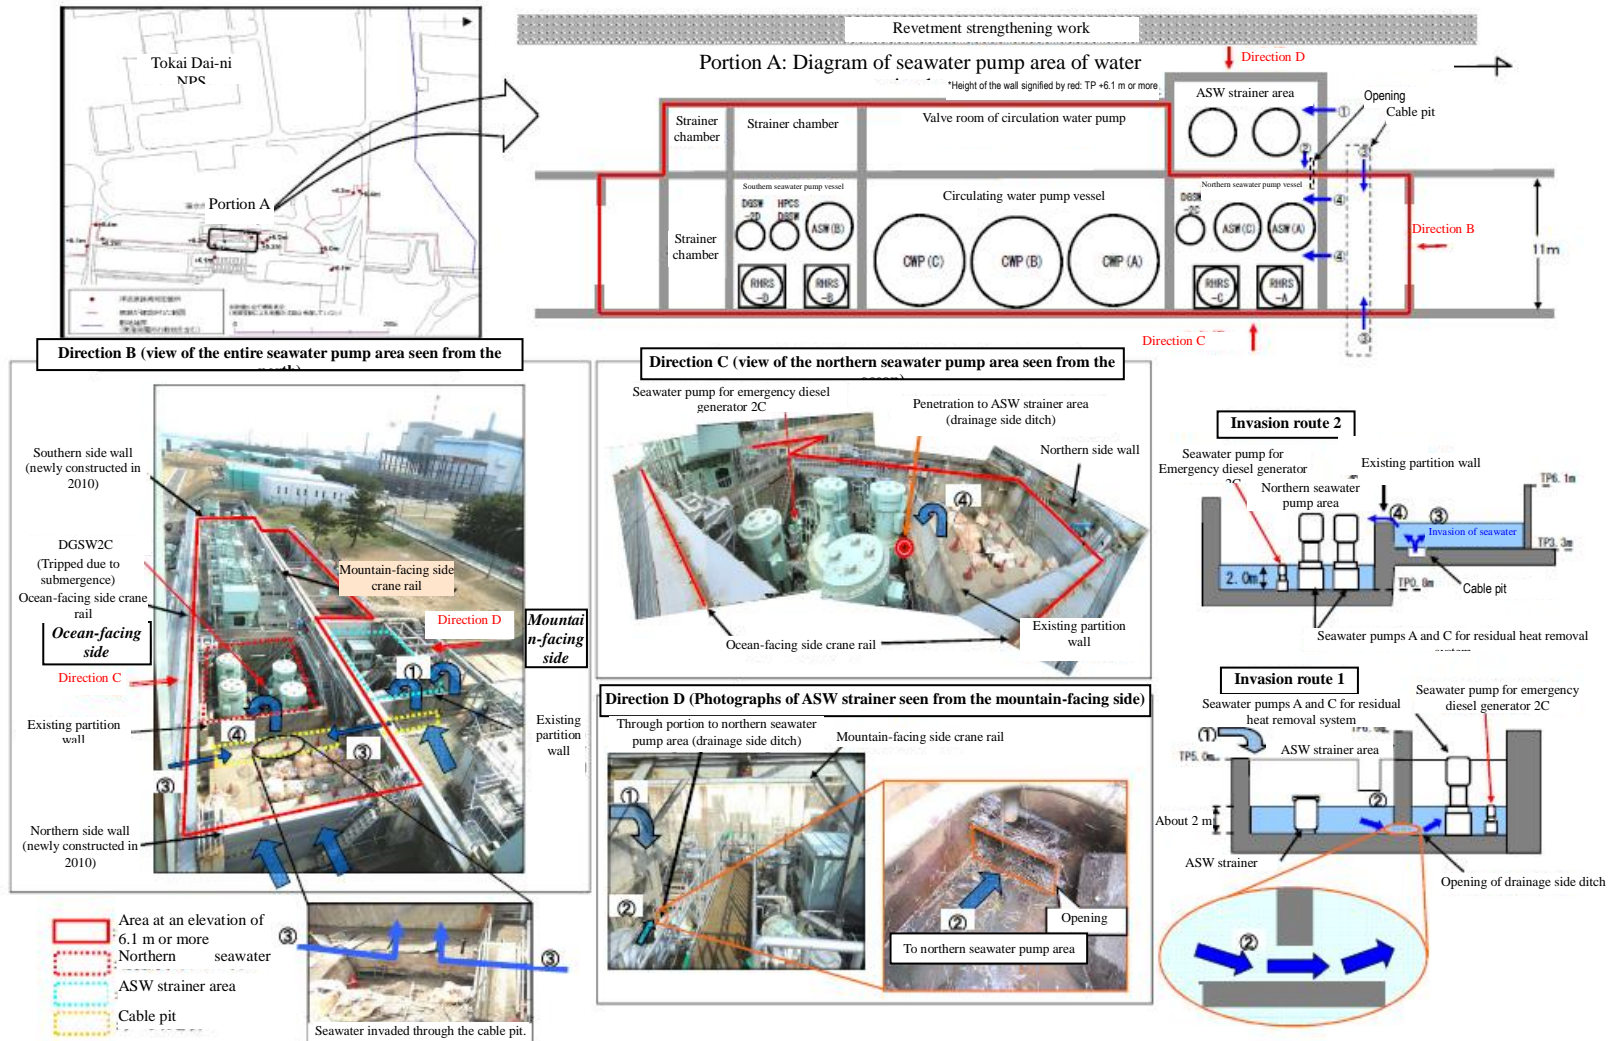
Fig. II-2-169 Photographs Showing Seawater Invading Routes in Northern Seawater Pump Area of Water Intake

➤ Inundation of pump tank and damage on equipment (Figures II-2-169 and II-2-170)

➤ Cause of inundation of north pump tank (Figure II-2-169)

- DGSW2C was restored through regular maintenance procedure after washing and drying the stator. The pump was subsequently restored to standby condition at 22:10 on March 22, 2011 following the integrity check operation of the emergency DG (2C).
- For the north pump tank, the drain to the ASW strainer areas and the cable pit was closed by concrete placement (Figure II-2-173).
- The power company has implemented emergency safety measures as further measures against tsunami, and plans to incorporate the knowledge that will be obtained through the overall investigation of the Great East Japan Earthquake.
