Additional Report of the Japanese Government  
to the IAEA

- The Accident at TEPCO's Fukushima Nuclear Power Stations -  
(Second Report)

September 2011

Nuclear Emergency Response Headquarters  
Government of Japan

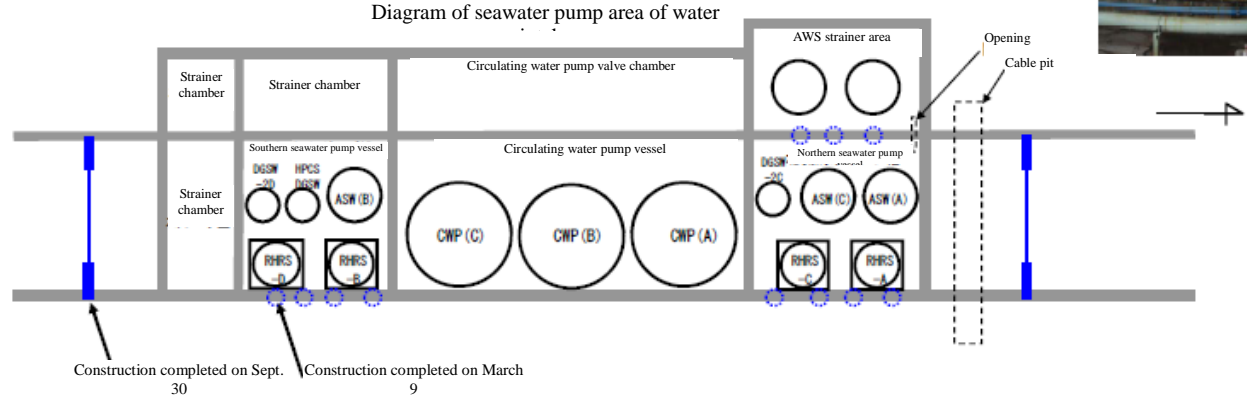
Fig. II-2-172 Status of Construction at Seawater Pump Area for Anti-tsunami Measures When Earthquake Occurred (March 11)

Construction name etc.	2010				2011				Notes
	4	7	10	1	4	7	10	1	
① Construction of new partition wall		June 6月	Sept. 9月						
		Construction completed on Sept. 20							
② Filling construction for piping penetration				Nov.					
				Filling construction for piping penetration (11) portions completed on					
③ Cable pit, filling construction for discharge channels					Feb. 2			End of	
				Filling construction for cable pits not completed
