Report of Japanese Government
to the IAEA Ministerial Conference on Nuclear Safety
- The Accident at TEPCO's Fukushima Nuclear Power Stations -

June 2011

Nuclear Emergency Response Headquarters
Government of Japan

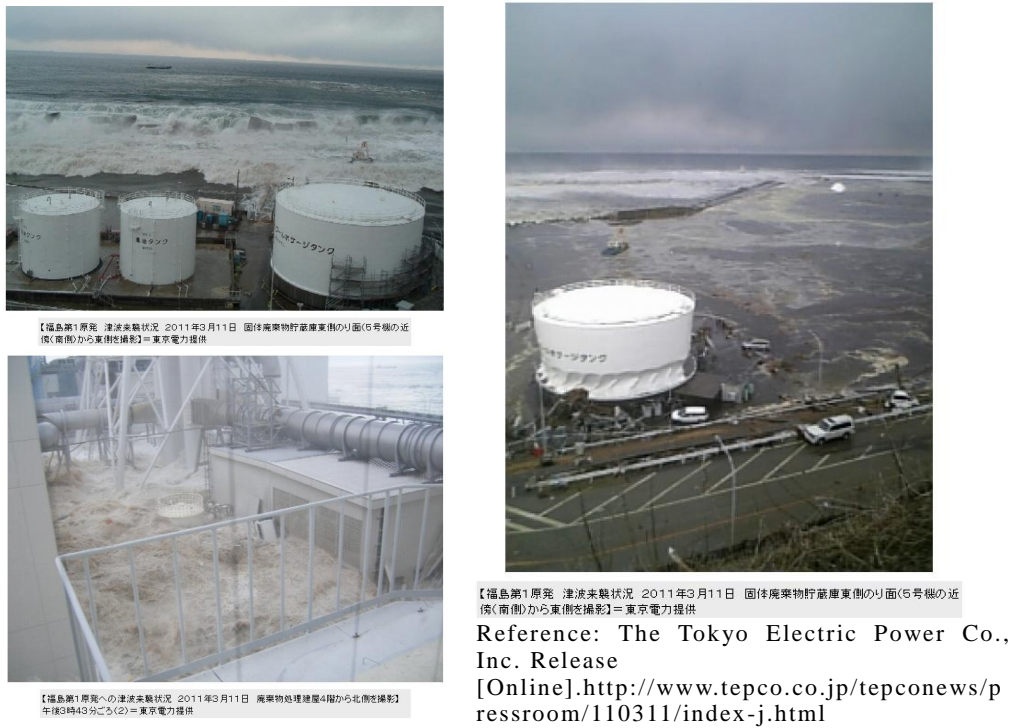
Fig. III-2-4(b) Photos showing plant damages at the Fukushima Dai-ichi NPS.

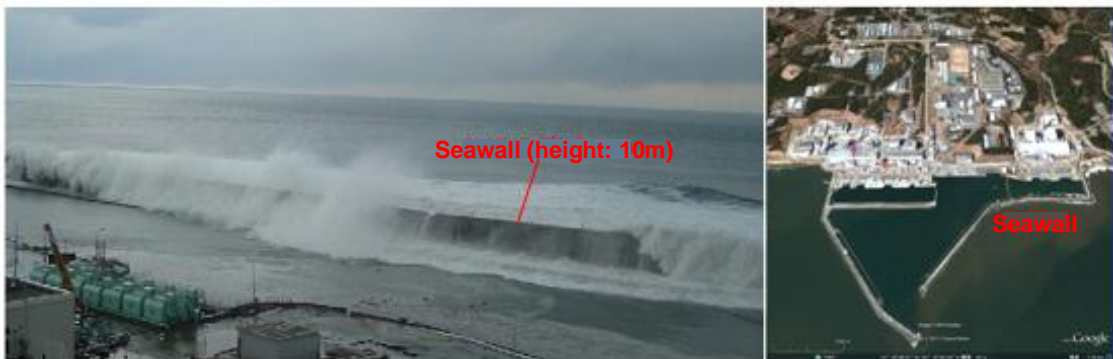
Cross section of Fukushima Dai-ichi (Unit-1)

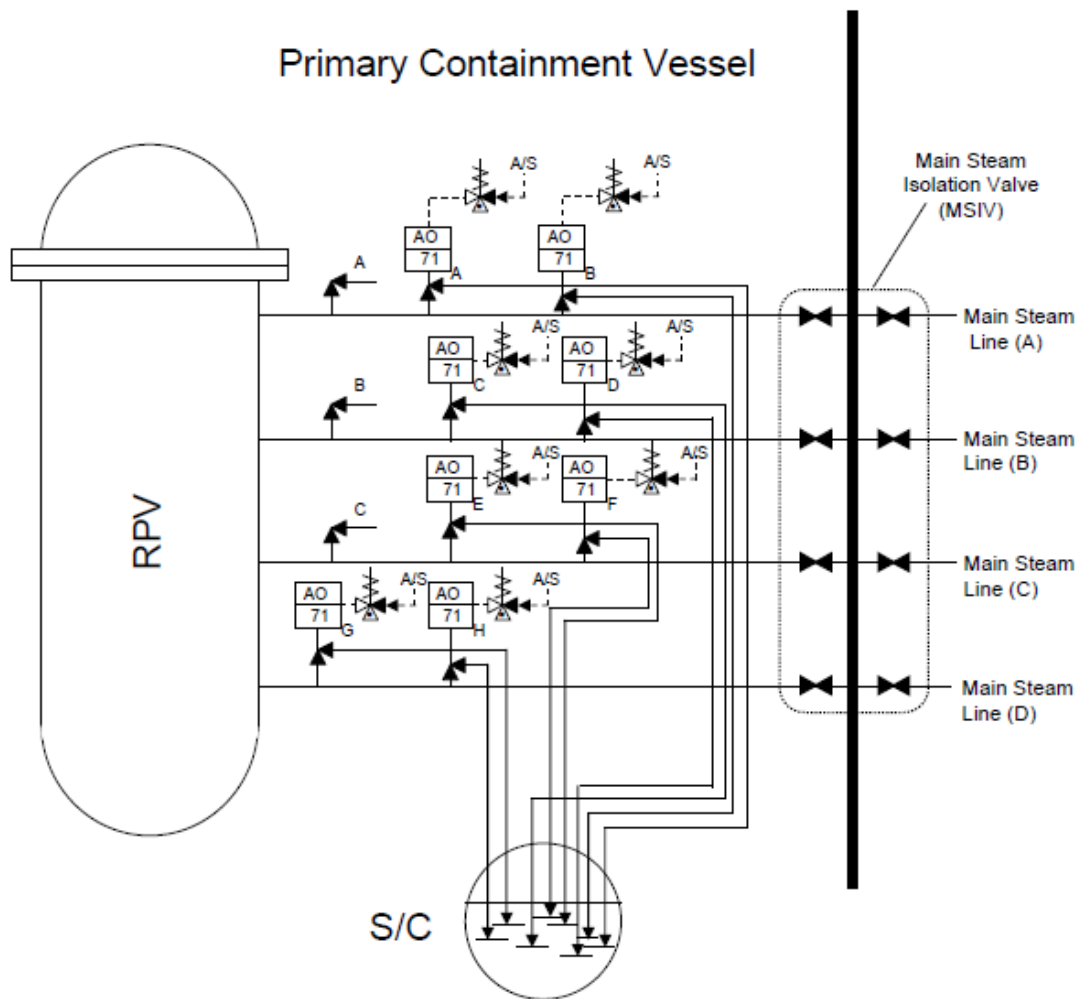
*1: Main steam safety relief valves (8 valves) are AO valves, and open drive air is supplied by the energized solenoid valves of air supply lines. During power loss, solenoid valves become deenergized and main steam relief valves are in a closed condition.

Fig. IV-2-7 System Structure Diagram of Main Steam Safety Relief Valve (Units 2 and 3)

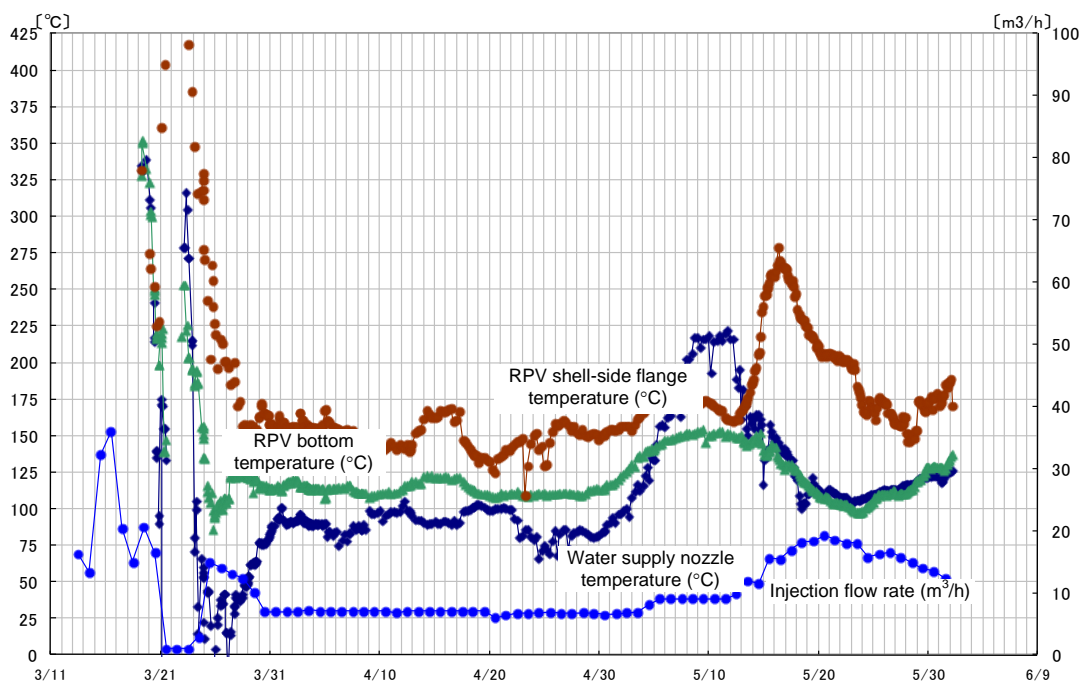
Figure IV-5-7 Changes of Main Parameters (1F-3) (March 11 to May 31)

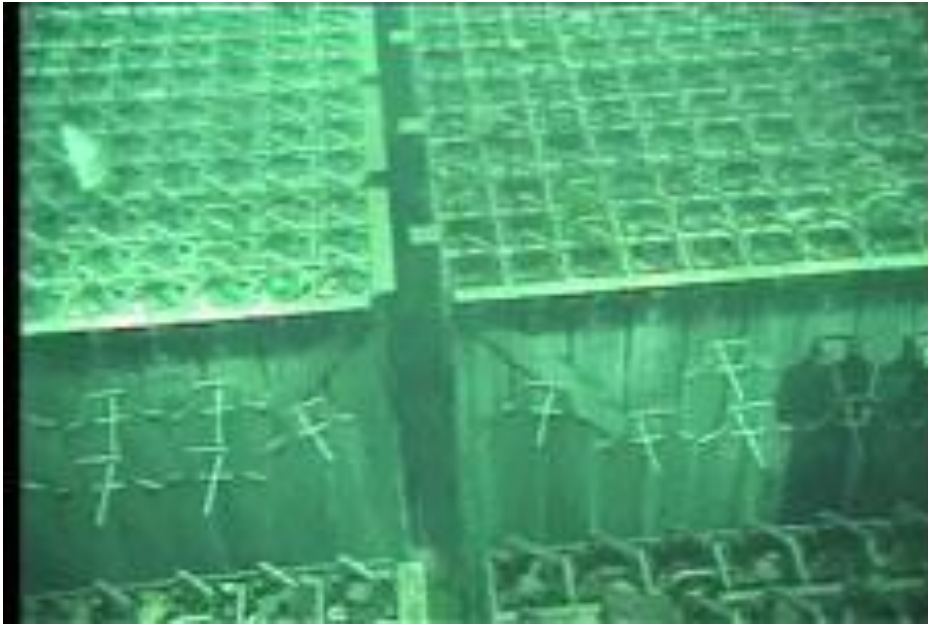
Fig. IV-5-12 Condition of the spent fuel pool (Unit 4)

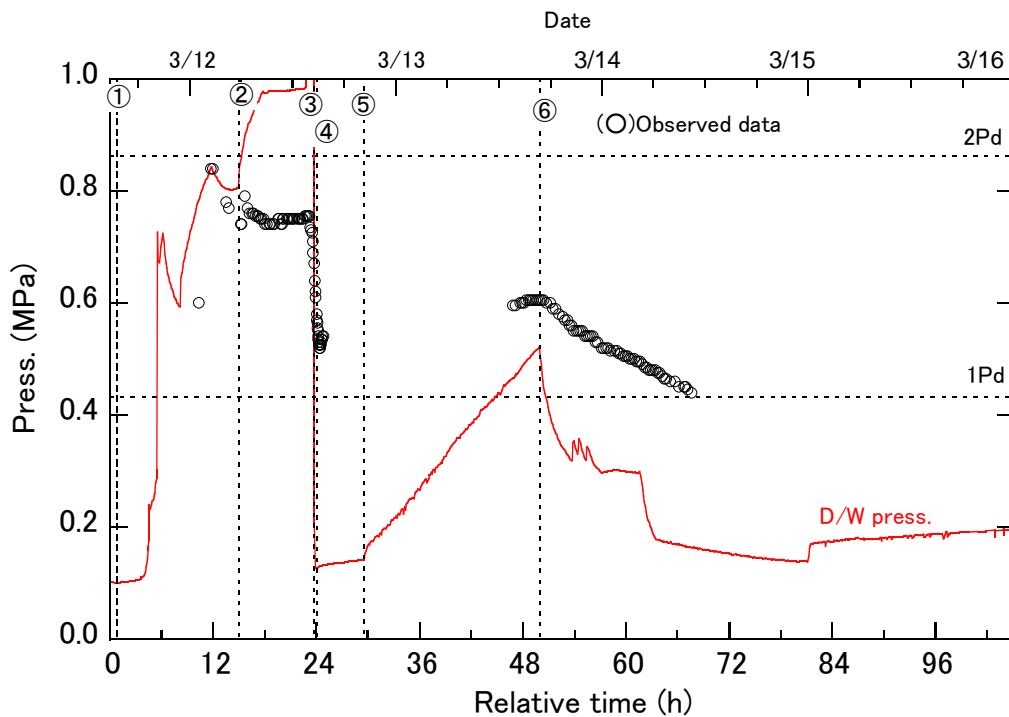
Fig. 1-1-2 D/W pressure (unit 1) [TEPCO]

①IC stop, ②PCV failure (assumption), ③W/W ventilation (open), ④W/W ventilation (close), ⑤ sea water inject., ⑥expansion of PCV failure (assumption)
